Phase I Environmental Site Assessment

Tribal Unit 45

Richardson's Sawmill

December 30, 2014

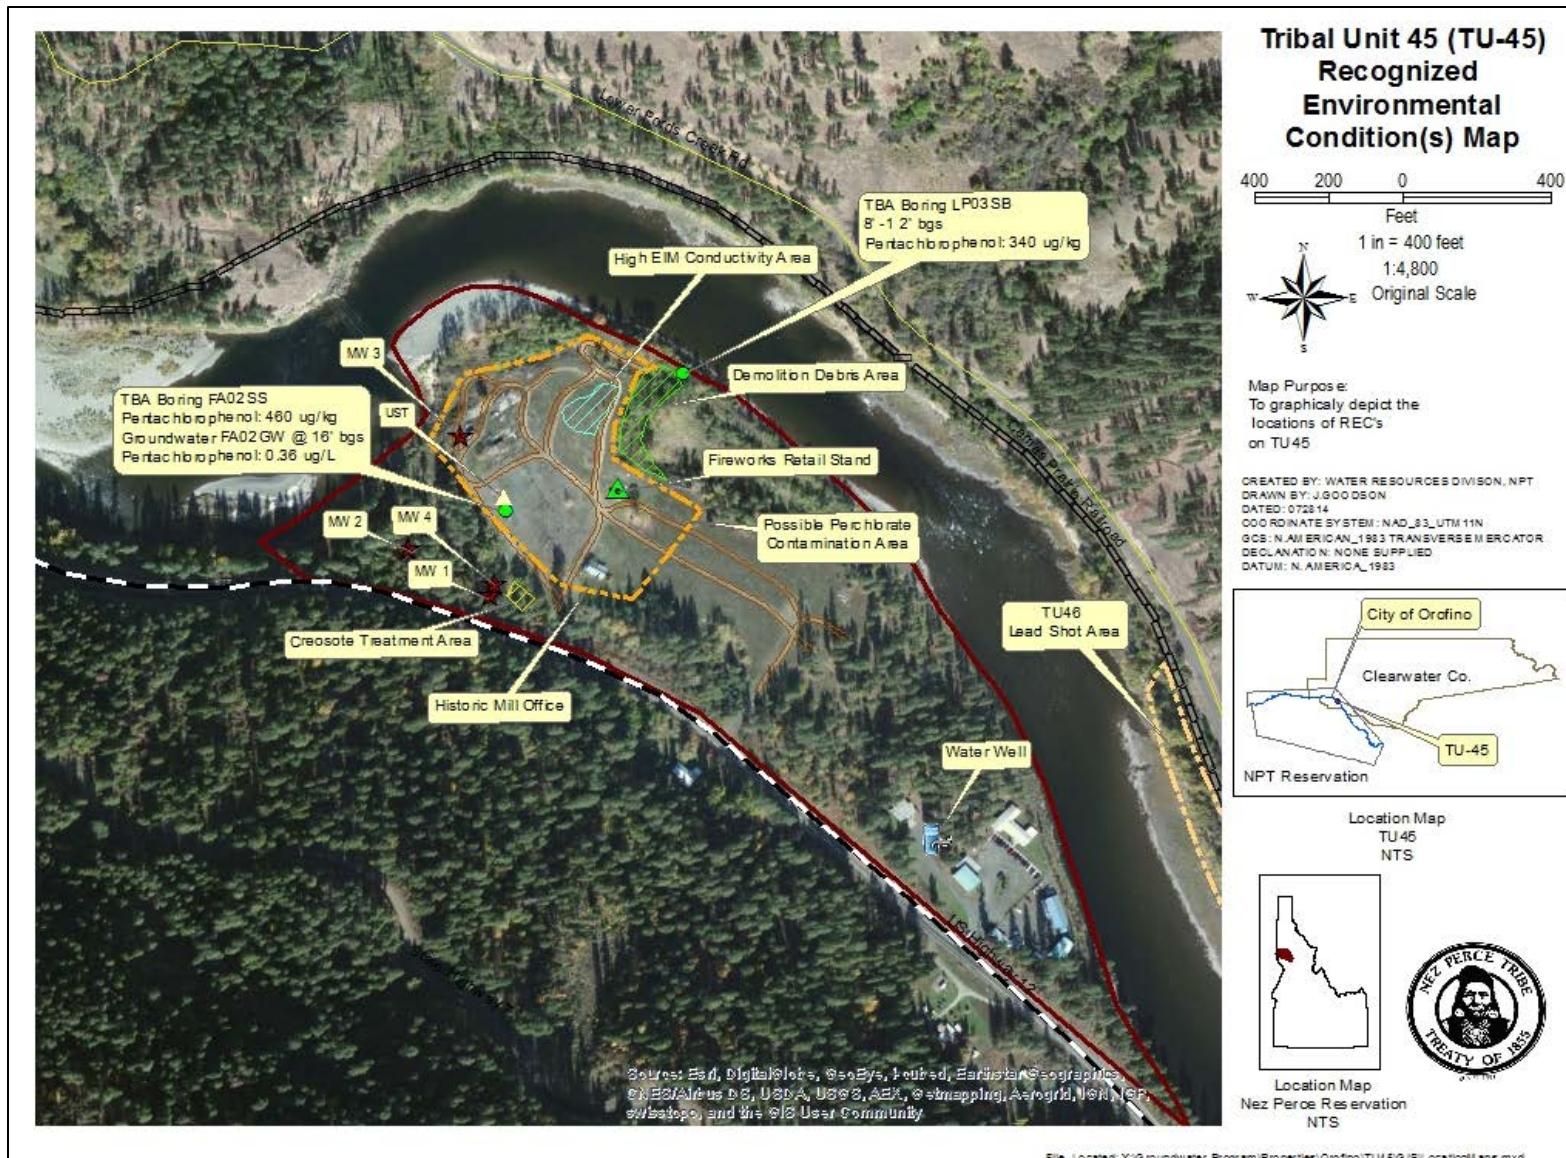
1. Creosote contaminated soil and possible creosote groundwater contamination
2. Underground Storage Tank (UST);
3. Uncharacterized "demolition debris"
4. Perchlorate contamination of groundwater from fireworks detonation
5. Soil and possible groundwater contamination by pentachlorophenol of unknown origin.

Figure 1. TU-45 Location Map and Recognized Environmental Conditions.

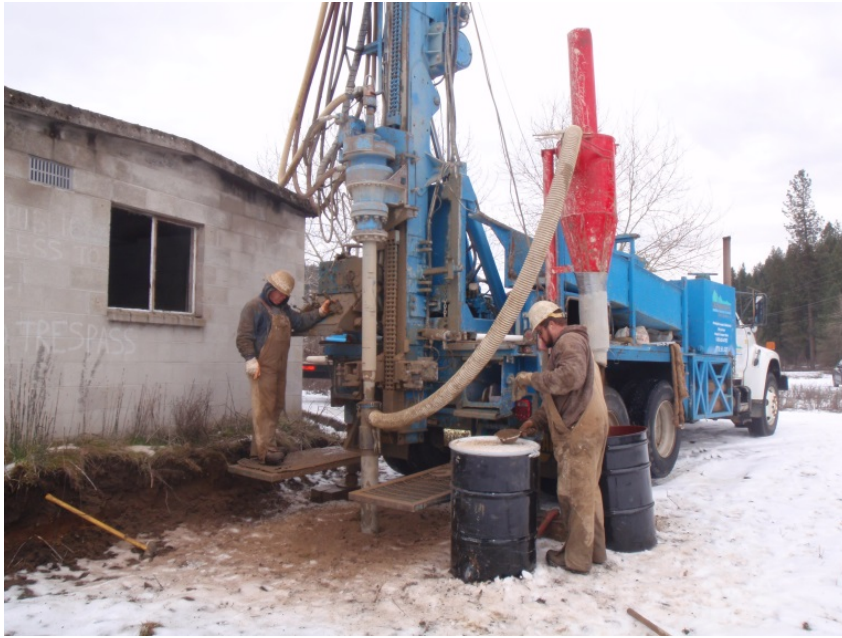
Monitor well MW#3 (35 ft. deep) was drilled 10 feet from east side of Transformer House as part of the Phase II ESA to assess the groundwater for PCB contamination (see Figure 1 and Figure 2). Groundwater has to date been sampled twice in MW#3; no PCB's were detected in drill cuttings or groundwater samples. During the second site visit with Dale Richardson in 2013, Mr. Richardson was questioned about the PCB cleanup. Dale described shoveling PCB contaminated soil into barrels until the Tribal representative told him the cleanup was adequate. Since the only chemical analysis from the initial cleanup was 182 ppb and no PCB contamination has been found during the TBA and the Phase II ESA, it is believed that the initial PCB cleanup was adequate and no further PCB assessment in this area is needed.

Figure 2. Drilling MW-3 adjacent to Power House

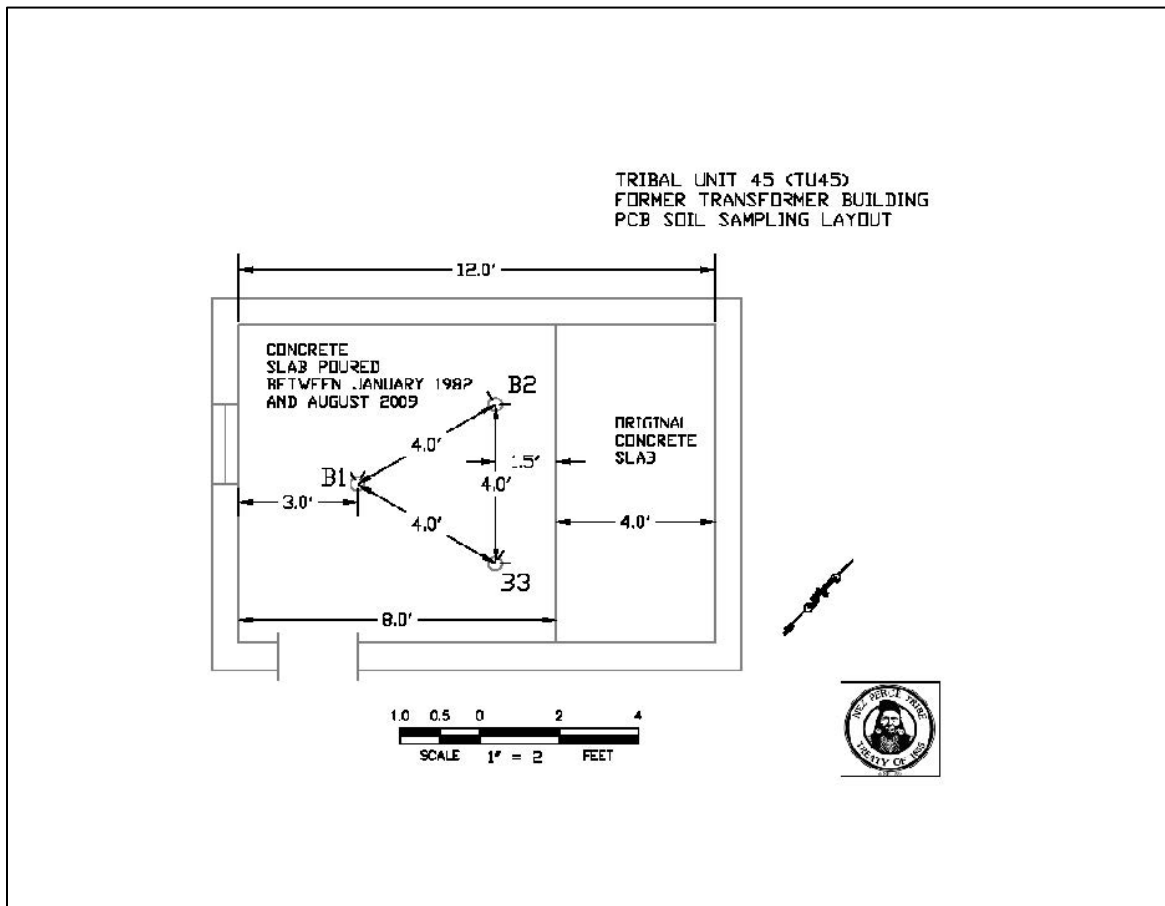
In 2013, Tribal staff rented a jackhammer and broke three holes in a triangular pattern in the newer concrete, and using sampling protocols established in the EPA-approved Environment and Ecology Sampling and Analysis Plan (SAP) (see Figure 3). Tribal staff collected three soil samples using a hand augur at depths of 1.7 to 2.2 ft and analyzed them for PCB (Aroclor) utilizing EPA 8082 at Anatek Labs, Moscow, ID. The analyses for all three samples were reported as non-detect with a practical quantitation limit (PQL) of 0.1 mg/kg (see Table 8). This investigation was documented in a report by Judy Goodson dated August 2, 2013.

Figure 3. Power House, PCB sample locations

Significant resources have been invested in documenting possible PCB soil and groundwater contamination. To date none has been found. The 1986 BIA letter appears to document either the original transformer oil contamination was not cleaned up or that new contamination occurred after Mr. D. Richardson's cleanup efforts. Also, Mr. Seth believes the original contamination was not cleaned properly. However, it appears that the oil contamination documented in 1986 is unrelated to the PCB spill. The TRP will continue to sample MW-3--located adjacent to the Transformer House--for another two quarters and analyze the water for PCB, in addition to the other contaminants of concern. Assuming that the groundwater continues to be non-detect for PCB, no additional work is recommended.

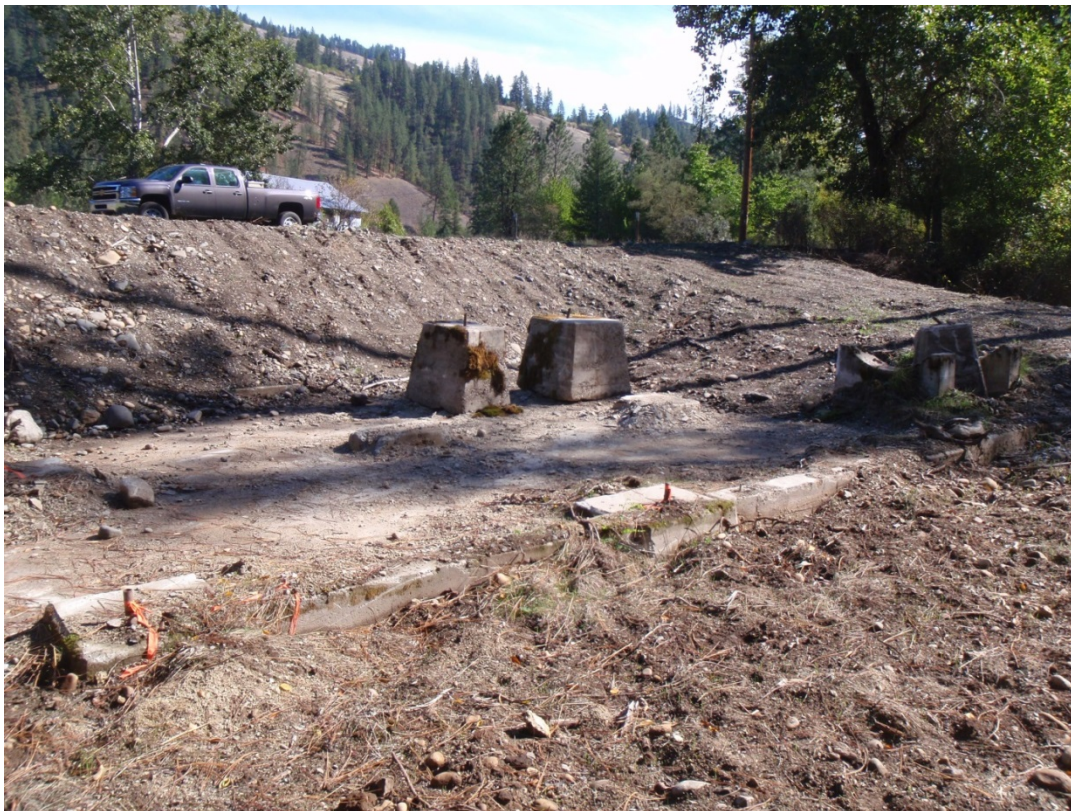
It should be noted that all soils sampled to date represent relatively dilute concentrations and are not representative of pure product. The observed chemical concentrations are highest at the deepest depths sampled with the soil boring with lesser concentrations in the overlying sediments. This suggests that creosote related chemicals may have spread laterally on top of the water table from the source area. It also suggests that we have not sampled in the source area, perhaps because the configuration of the treatment facility is not well understood. Because these chemicals are both non-polar and predominantly denser than water, a pulse of free product may have infiltrated the sediments and lie pooled on the underlying crystalline bedrock, anticipated to lie 40-50 ft. below ground surface.

Figure 4. Creosote treatment area, 2013.

Table 10 summarizes the groundwater samples collected from the four monitoring wells and the drinking water well to date. Only traces of SVOCs were detected in one well (MW-4) and these do not exceed IDTL concentrations. However, post drilling interpretation of the groundwater flow direction is approximately 45 degrees to the original hypothesized groundwater flow direction prior to drilling. The traces of SVOC in MW-4 and soil sampling and previous TBA borehole analysis suggest that additional drilling on the north side of the creosote treatment area is warranted.

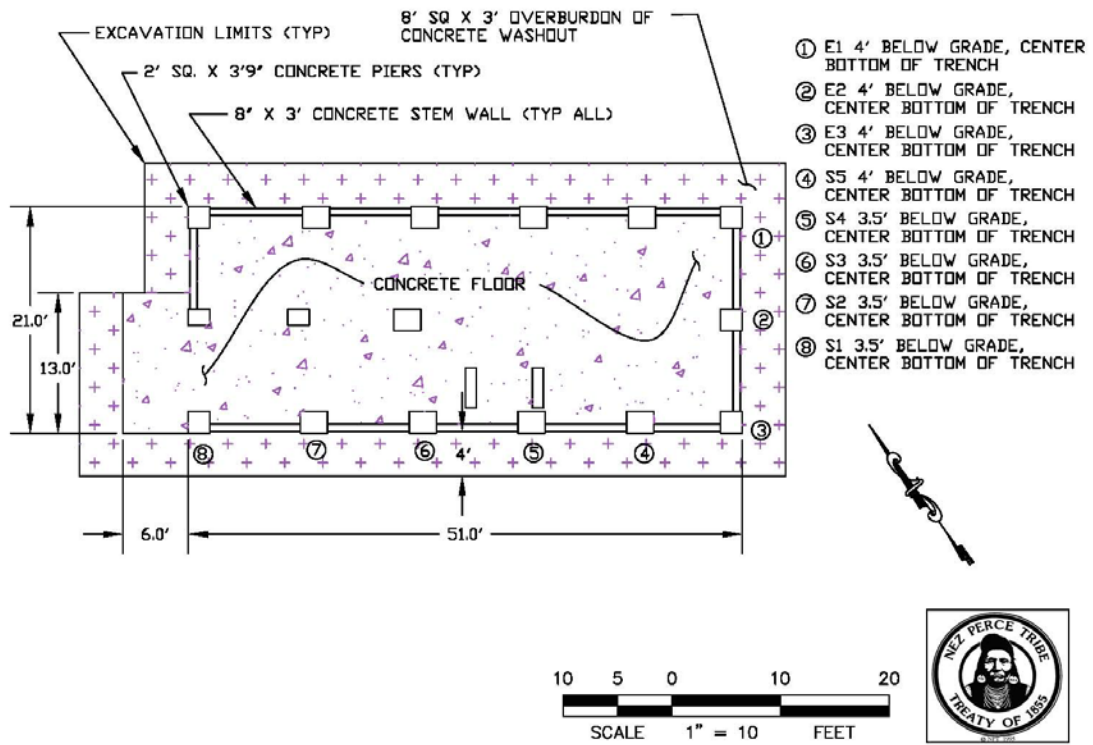
TU 45 CREOSOTE INVESTIGATION CONDUCTED 08/06/13
 REMAINING FOOTPRINT AND SAMPLING LOCATIONS

Figure 5. Creosote treatment area soil sample locations.

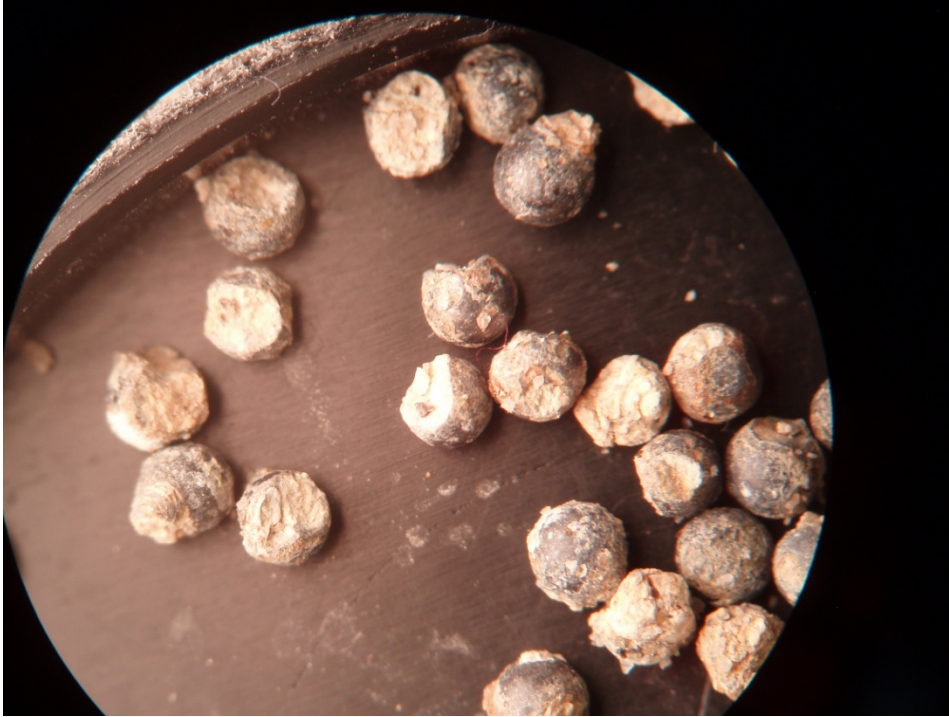
Figure 6. Lead shot collected from riverbank of TU-46 downrange of Orofino Trap House.

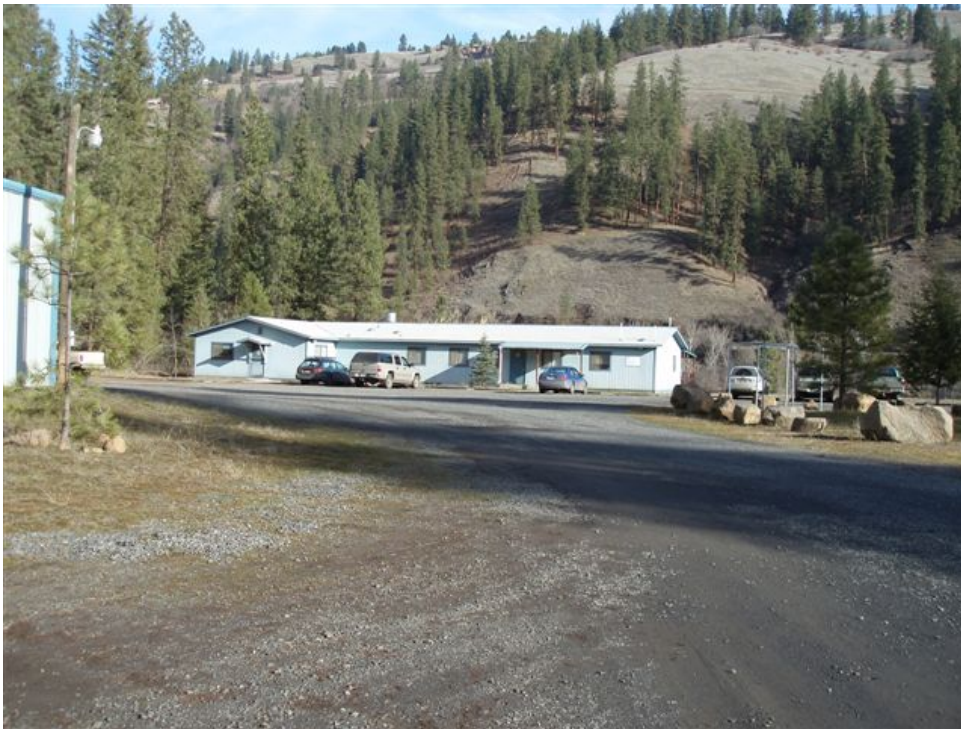
In an interview with Sherman Sprague, NPT Fisheries employee, he stated the trap house was under the current footprint of the Fisheries office. He reported seeing broken clay pigeons and spent shells on the ground prior to the development of the Fisheries office (see Figure 7). The TBA collected numerous surficial sediment samples in the vicinity of the Trap House, but did not document a significant quantity of contamination. However, they could not physically reach the down range portion of the site on TU-46 so no samples were collected there.

Figure 7. Current location of Fisheries office/site of Orofino Gun Club Trap House

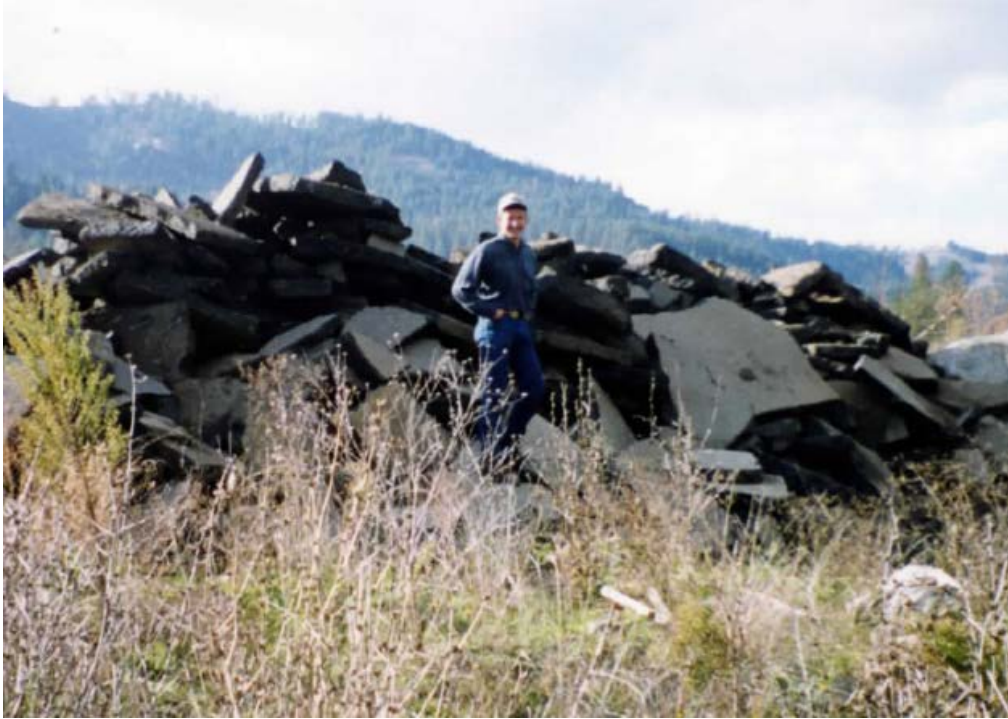
According to BIA and NPT Land Services files, WASCO, Inc, illegally dumped four truck loads of demolition debris on the banks of the log pond at TU-45 on October 27, 1998. Mr. Strom, a WASCO, Inc. employee, thought that the company had permission to dump fill material and rock at TU-45. Photographs taken at the time of the incident depict broken asphalt and concrete (Figure 8).

Figure 8. Waste materials dumped at log pond by WASCO, Inc. in 1998.

The TRP believes that the possibility of waste materials buried around the log ponds deserves further investigation. The physical characteristics should be determined as they may be an impediment to site redevelopment and landscaping. Additionally, they may contain materials that are harmful to the environment. The presence of the electro-magnetic conductivity anomaly may represent hazardous materials and should be investigated with trenching, visual characterization, and chemical analysis, if warranted.

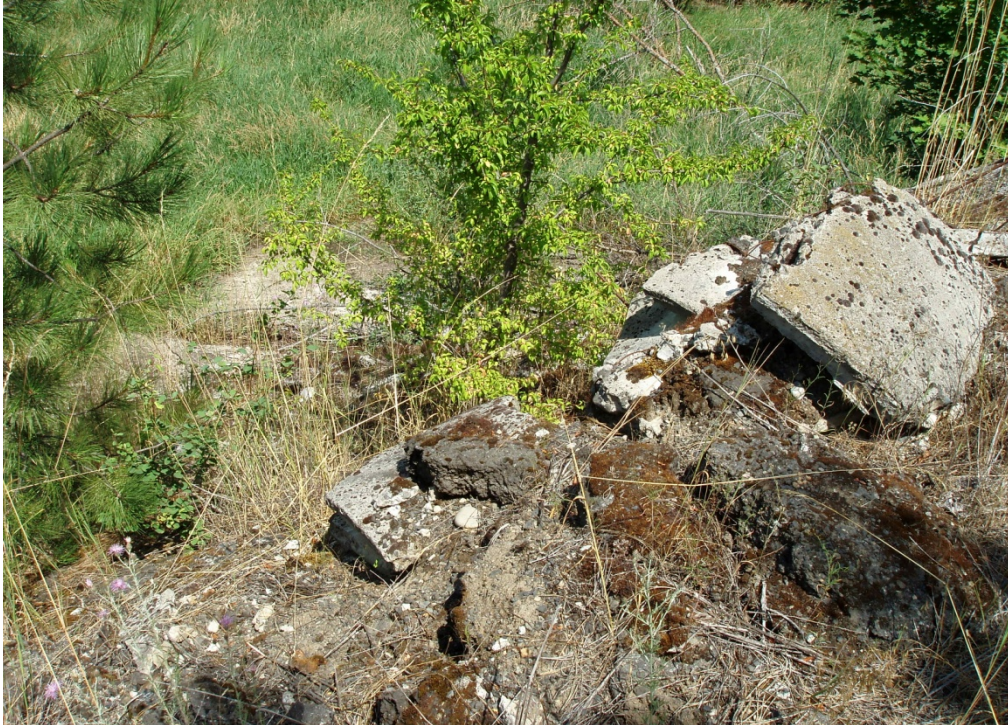
Figure 9. Present day photograph of waste materials dumped at log pond.

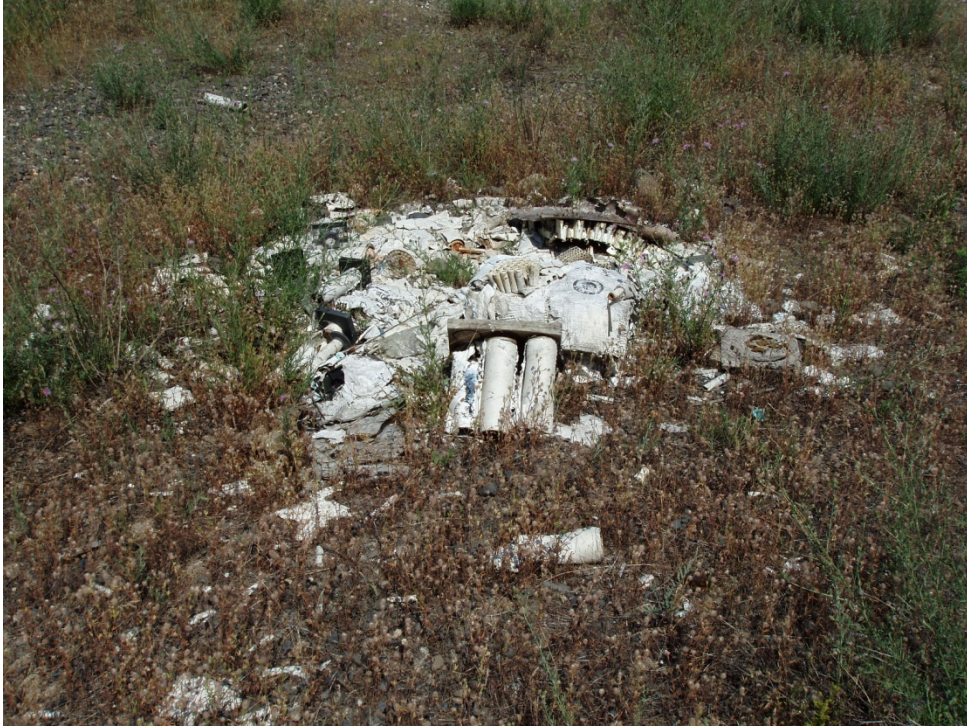
Seasonal fireworks stands have operated at TU-45 from 1991 to 1997 and again through 2014. While the intervening years are not well documented it is likely that fireworks are seasonally sold at TU-45 as an ongoing practice. The TRP observed three or four piles of highly weathered discarded fireworks on the property (Figure 10). Initially, it was thought that the fireworks were unexploded, but later it was concluded that the solid material at the base of the fireworks was probably a clay weight used to stabilize the firework during ignition.

Figure 10. Fireworks discarded at TU-45.

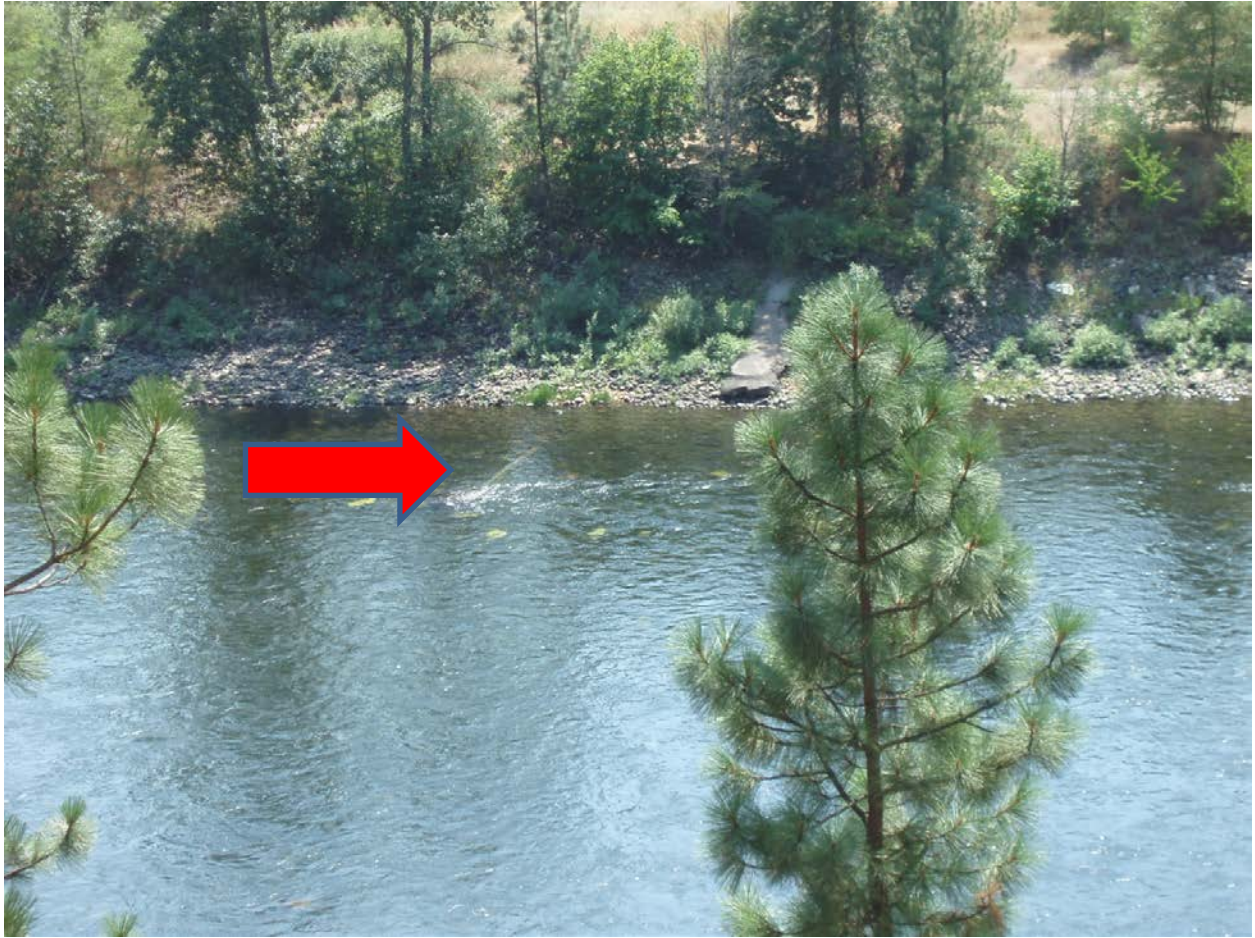
Figure 13. Riverside Sawmill water intake pipe in Clearwater River.

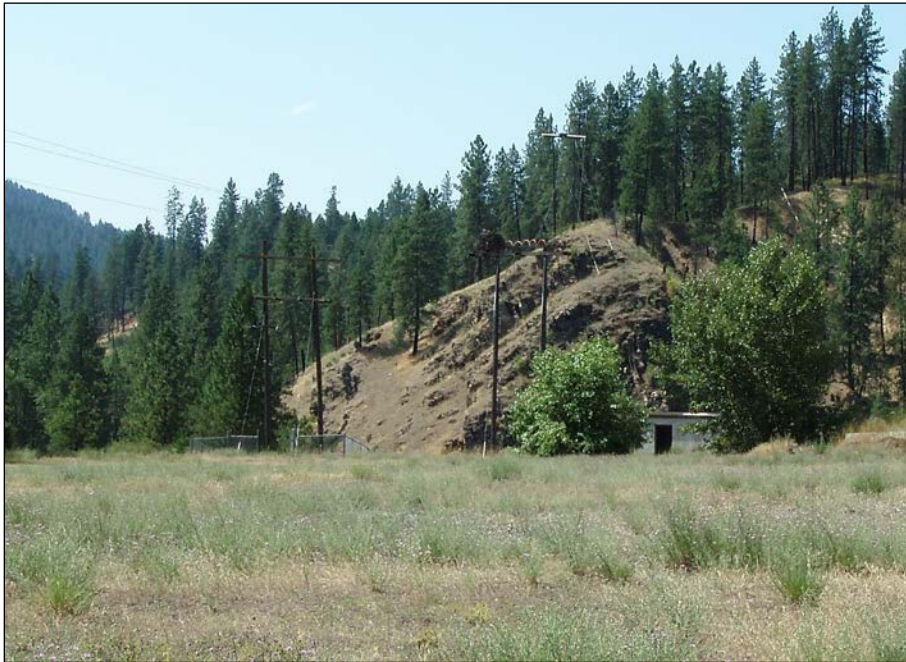
Figure 1, Transformer sites; cinder block transformer building and fenced power poles in background.

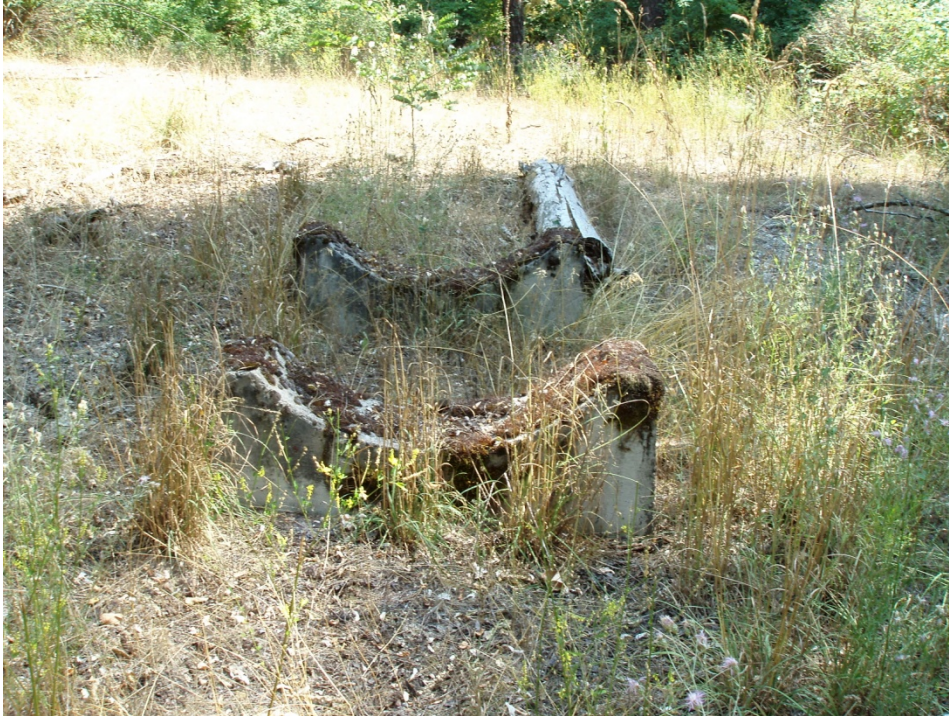
Figure 2; Concrete support saddles for creosote air-lift pressure tank, Richardson Saw Mill site, TU 45.

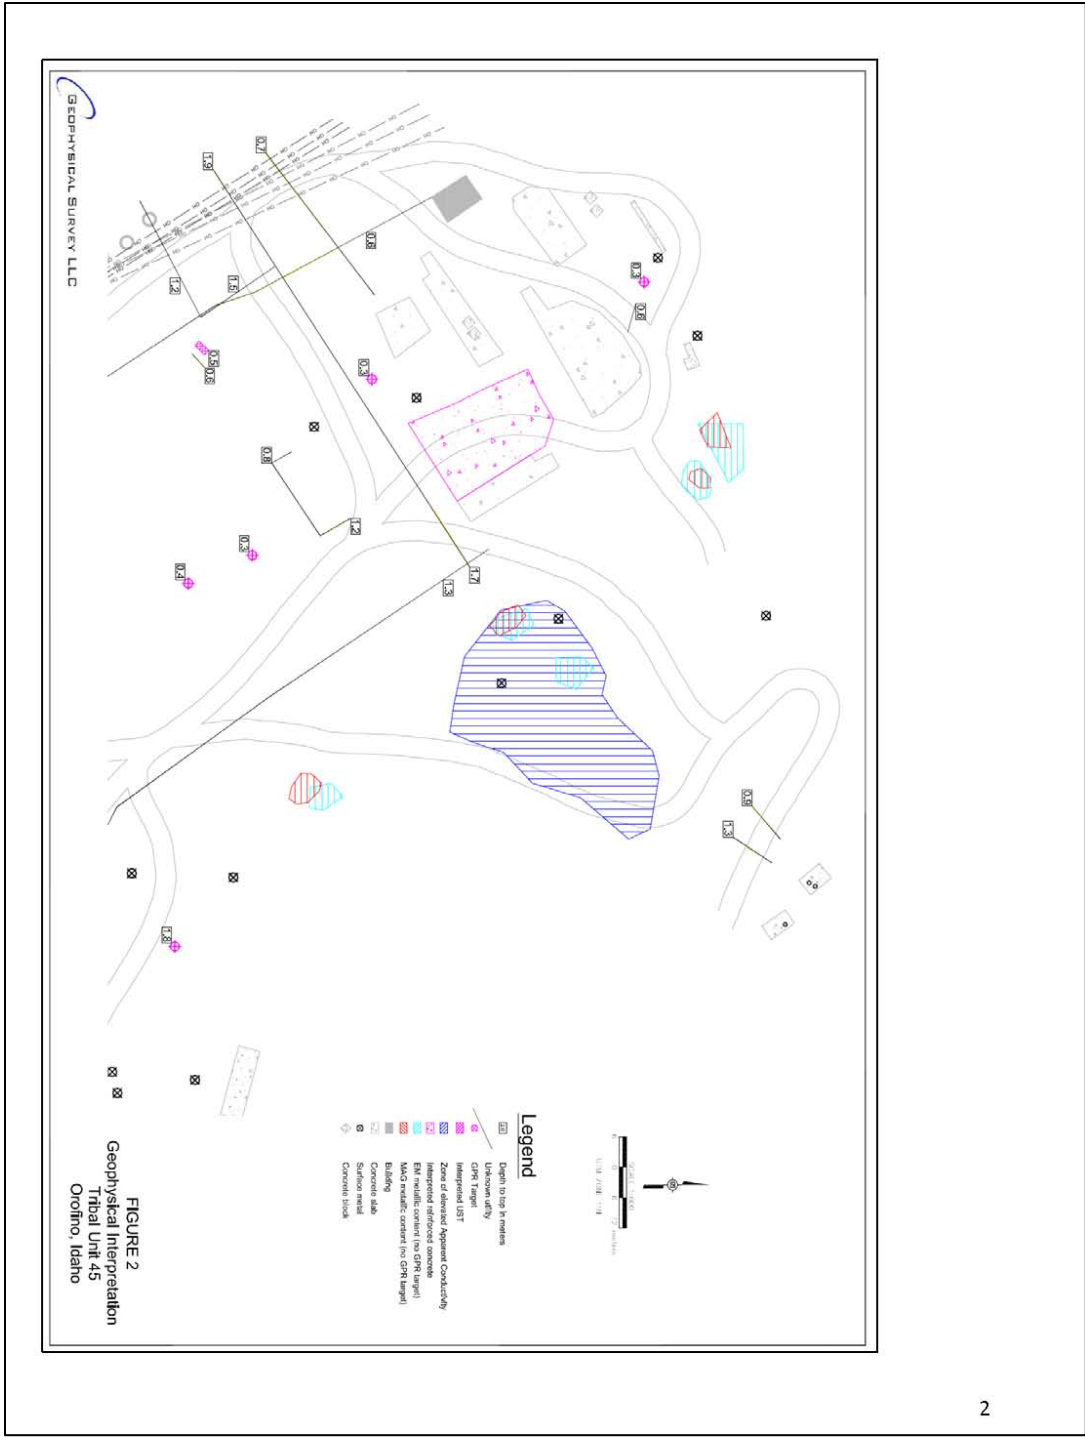
In March 2013, the Nez Perce LUST Assessment Program contracted with Geophysical Survey LLC to evaluate five separate locations on the Reservation for the presence of USTs, including the approximate 30 x 30 meter area identified by Mr. Richardson at TU-45. A Geophysical Site Investigation Report was submitted to the Tribe on March 16, 2013 and stated that no tank was found in this survey at TU-45, although a buried utility line and buried debris 1-2.8 meters deep were found. The geophysicist stated the former mill site “would be conducive to a magnetometer or EM-31 survey with GPS navigation for a complete UST investigation of the area.” The Tribe again contacted with Geophysical Survey to search a larger area on the property, including the area previously investigated. In a report dated 12/31/2013 the contractor identified a 300-500 gallon UST at a location independent of the Gas House (Appendix 6).

Figure 14. Geophysical map showing location of UST

Previous experiences with USTs on the Reservation suggest that approximately 30% leaked and that they should all be decommissioned, removed by excavation (where possible) and the soil sampled for VOCs. At that time the magnitude of contamination can be assessed and an appropriate decision made as to subsequent remediation. A review of Figure 1 shows that there is a 50 ft separation between the location of the penta contaminated boring and the location of the UST identified by geophysics. This suggests the remote possibility that the UST may be related to the use of penta at the site. Out of an abundance of caution, soil samples collected in the vicinity of the UST should also be analyzed for penta.

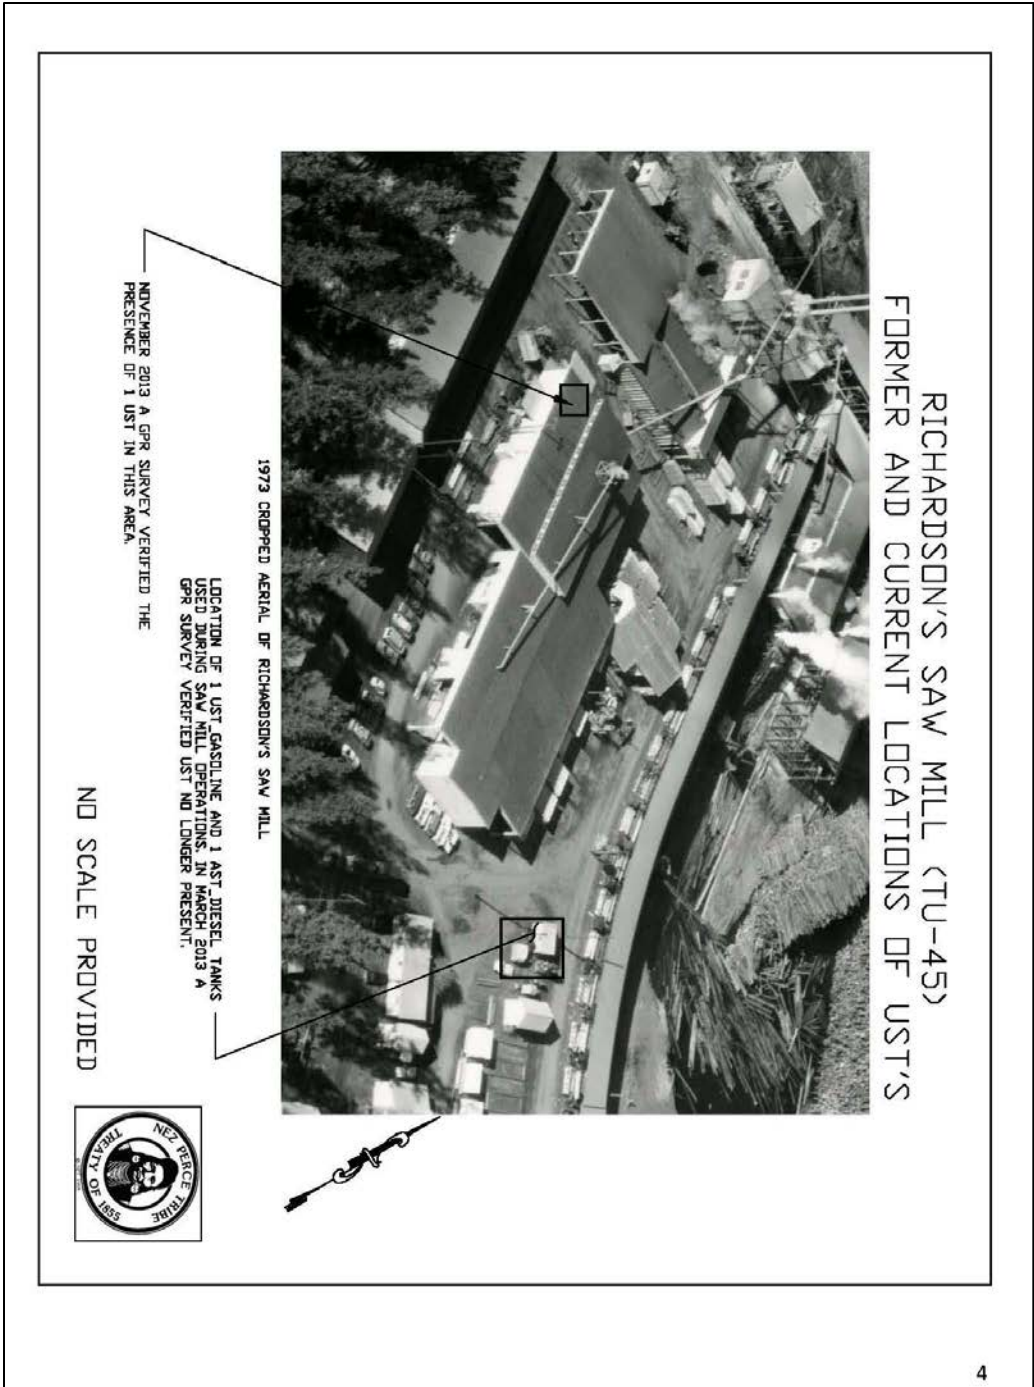
Figure 15. 1973 aerial photo showing location of fuel tanks used by sawmill and location of UST identified by geophysics.
