Hazardous Building Materials Survey – Multiple Buildings

Fort Lapwai Lapwai, Idaho

E & E Project No. 1004530.0380.015.01 TO-0380-015

November 2020

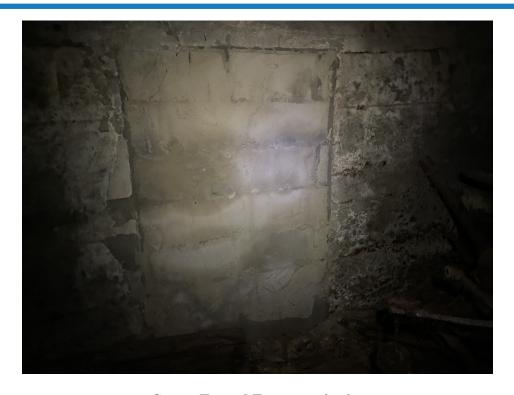
The steam tunnels were inaccessible during EHSI's survey. No access could be located in the West, North and East buildings. It should be noted that EHSI did observe a concrete infill at an assumed entrance to the steam tunnels in the North building basement. To our knowledge, we do not believe

Steam Tunnel Entryway in the Basement of the North Building that has been filled in with concrete

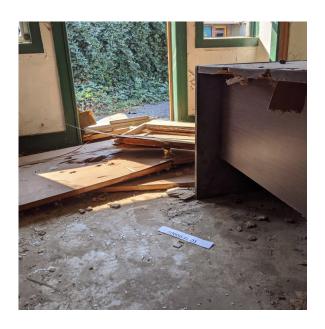
- **348 SF** Sheet vinyl flooring (SVF) (beige with broken rock pattern) beneath SVF (off-white with leaf pattern) on top of concrete located in the Main Entrance and Northeast adjacent room.

PHOTO #50000-FL-01: Non-ACM SVF over ACM SVF (beige w/broken rock pattern)

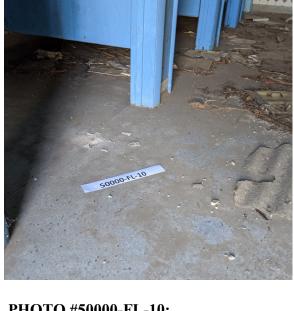
PHOTO #50000-FL-10: Non-ACM SVF over ACM mastic (black)

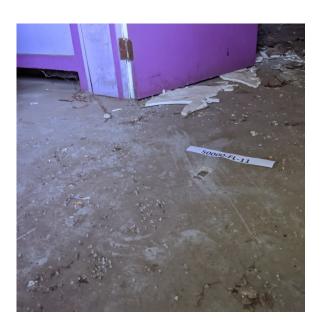
PHOTO #50000-FL-11: Non-ACM SVF over ACM mastic (black)

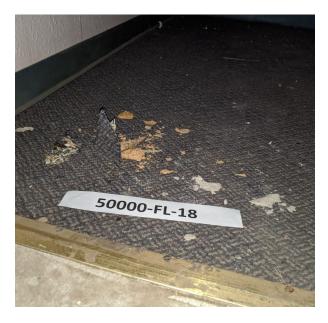
PHOTO #50000-FL-18: Non-ACM carpet over ACM VAT (green) over ACM mastic (black)

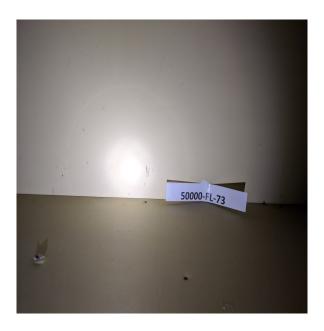
PHOTO #50000-FL-73: ACM joint compound (tan) over non-ACM GWB ceiling

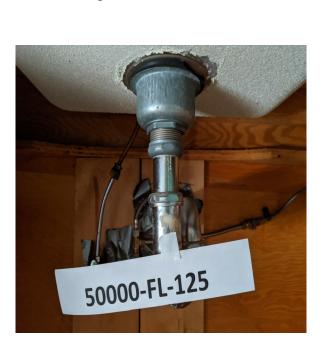
- 1 EA White sink undercoat located on stainless steel sink on the first floor in Room 1
- 1 EA Mastic (black) behind 16'x4' chalkboard unit located in the Northwest Classroom.

PHOTO #50000-FL-125: ACM white sink undercoat (on single stainless-steel sink)

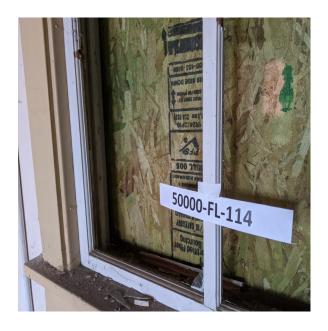
PHOTO #50000-FL-114: ACM window glazing putty (gray) on 3'1"x6'2" wood-framed windows

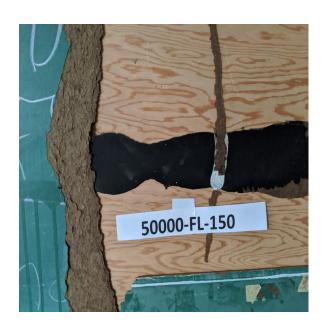
PHOTO #50000-FL-150: ACM mastic (black) behind 16'x4' chalkboard

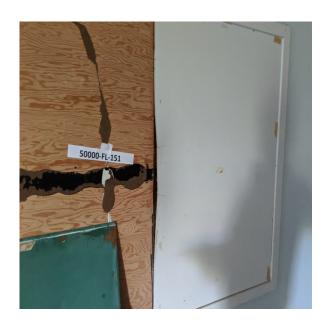
PHOTO #50000-FL-151: ACM mastic (black) behind 16'x4' chalkboard

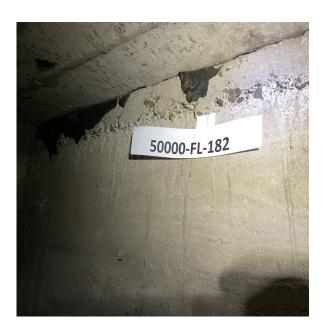
PHOTO #50000-FL-182: ACM vapor barrier (black, asphaltic/fibrous) on concrete ceiling

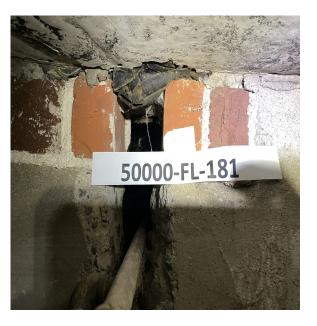
PHOTO #50000-FL-181: ACM vapor barrier (black, asphaltic/fibrous) on concrete ceiling

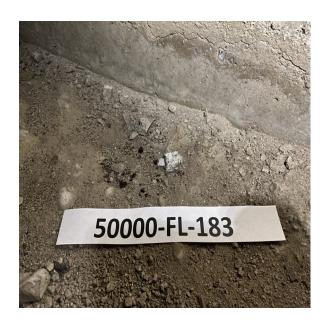
PHOTO #50000-FL-183: ACM TSI (white, powdery) debris

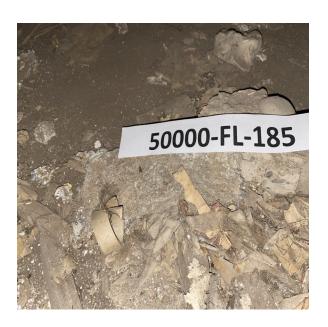
PHOTO #50000-FL-185: ACM TSI (white, powdery) debris

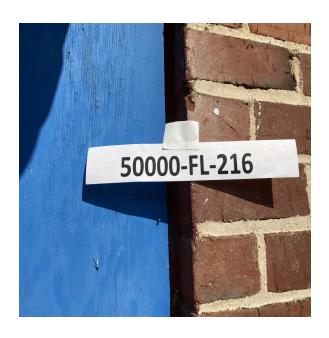
PHOTO #50000-FL-216: ACM door frame caulking (tan, brittle)

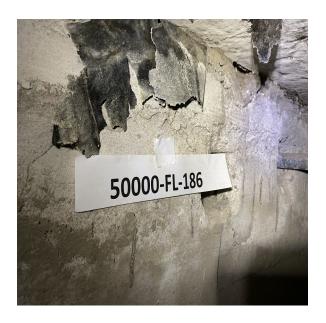
PHOTO #50000-FL-186: ACM vapor barrier (black, asphaltic/fibrous) on concrete ceiling

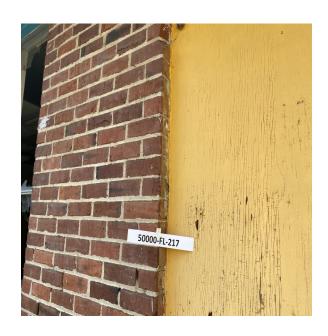
PHOTO #50000-FL-217:
ACM door frame caulking (tan, brittle)

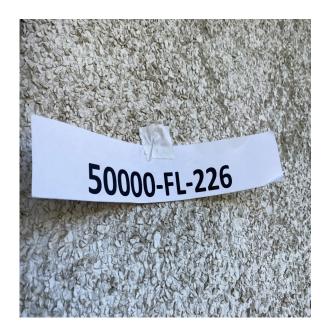
PHOTO #50000-FL-226: ACM Marble Crete (white)

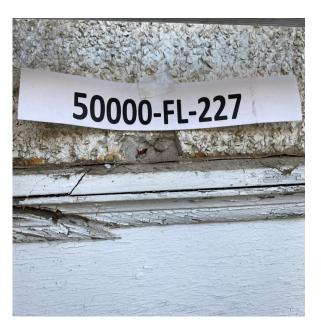
PHOTO #50000-FL-227: ACM Marble Crete (white)

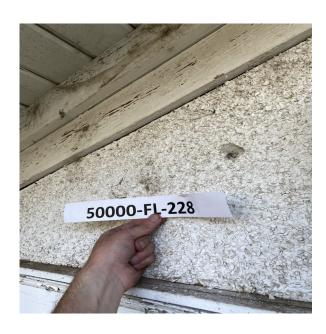
PHOTO #50000-FL-228: ACM Marble Crete (white)

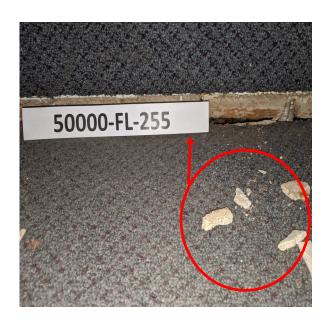
PHOTO #50000-FL-255: ACM unfinished plaster (gray/tan) behind non-ACM GWB wall

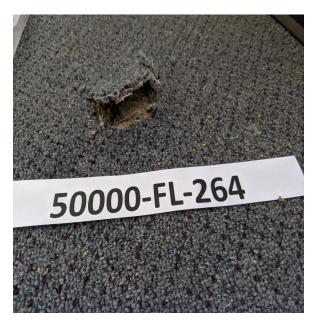
PHOTO #50000-FL-264: Non-ACM carpet on ACM VAT (light brown) on ACM mastic (black)

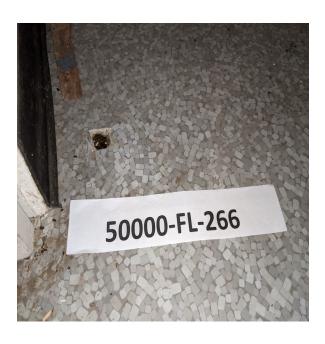
PHOTO #50000-FL-266: Non-ACM SVF on ACM VAT (light brown) on ACM mastic (black)

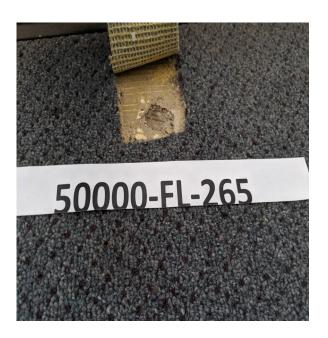
PHOTO #50000-FL-265: Non-ACM carpet on ACM VAT (light brown) on ACM mastic (black)

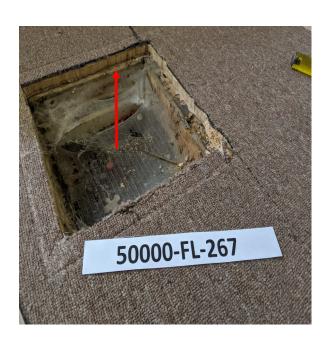
PHOTO #50000-FL-267: Non-ACM carpet (light brown) on ACM VAT (light brown) on ACM mastic (black)

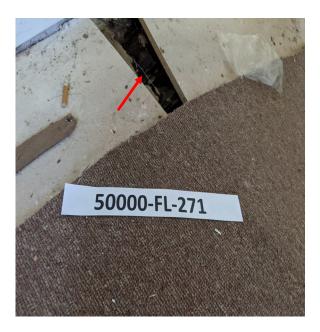
PHOTO #50000-FL-271:
Non-ACM carpet on ACM SVF (green)

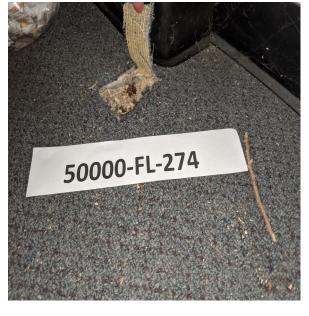
PHOTO #50000-FL-274: Non-ACM carpet on ACM VAT (light brown) on ACM mastic (black)

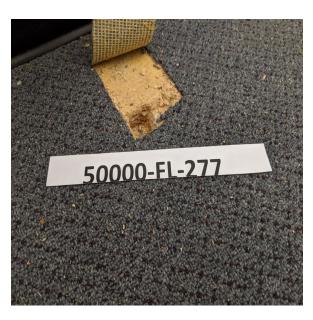
PHOTO #50000-FL-277: Non-ACM carpet on ACM VAT (light brown) on ACM mastic (black)

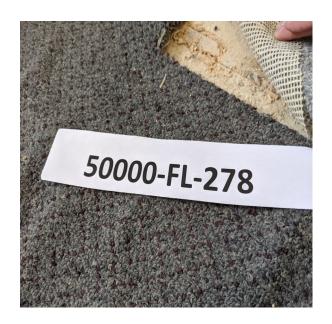
PHOTO #50000-FL-278: Non-ACM carpet on ACM VAT (light brown) on ACM mastic (black) (photo taken before sample collected)

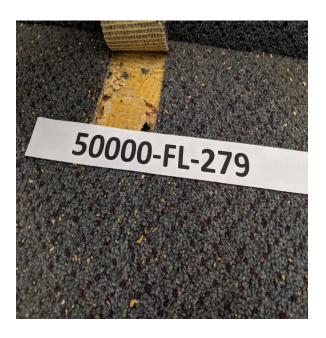
PHOTO #50000-FL-279: Non-ACM carpet on ACM VAT (light brown) on ACM mastic (black)

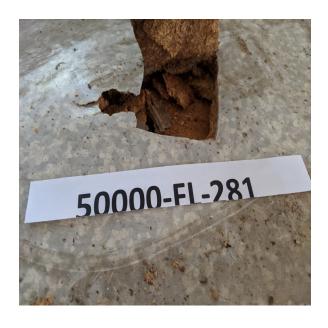
PHOTO #50000-FL-281: Non-ACM SVF on ACM VAT (light brown) on ACM mastic (black)

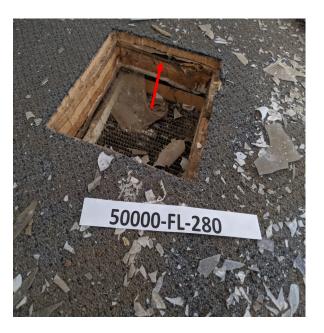
PHOTO #50000-FL-280: Non-ACM carpet on ACM VAT (light brown) on ACM mastic (black)

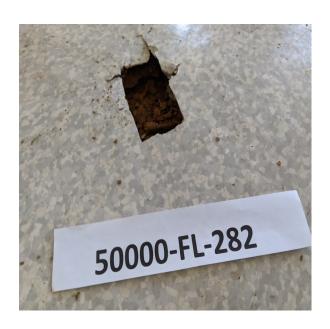
PHOTO #50000-FL-282: Non-ACM SVF on ACM VAT (light brown) on ACM mastic (black)

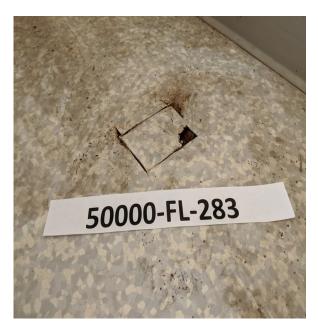
PHOTO #50000-FL-283: Non-ACM SVF on ACM VAT (light brown) on ACM mastic (black)

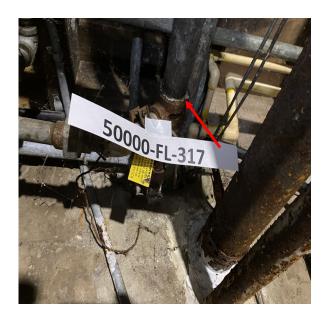
PHOTO #50000-FL-317: ACM pipe dope (tan, brittle) around 1" OD and 2" OD pipe fittings

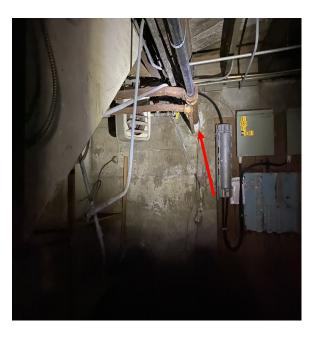
PHOTO #50000-FL-316: ACM gray fibrous packing material around 3" OD and 1" OD pipe penetrations

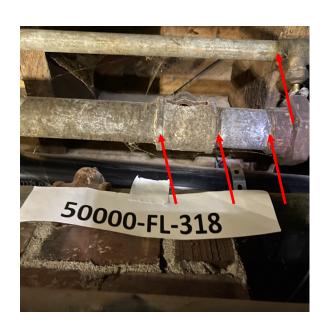
PHOTO #50000-FL-318: ACM pipe dope (tan, brittle) around 1" OD and 2" OD pipe fittings

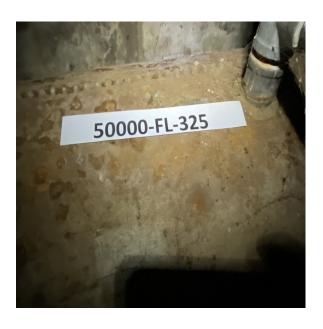
PHOTO #50000-FL-325: ACM paint (silver) on 5'x 2'x 2' water expansion tank

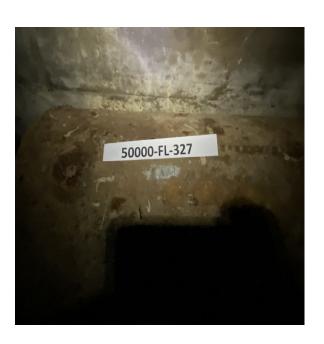
PHOTO #50000-FL-327: ACM paint (silver) on 5'x 2'x 2' water expansion tank

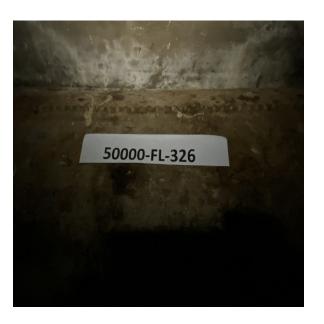
PHOTO #50000-FL-326: ACM paint (silver) on 5'x 2'x 2' water expansion tank

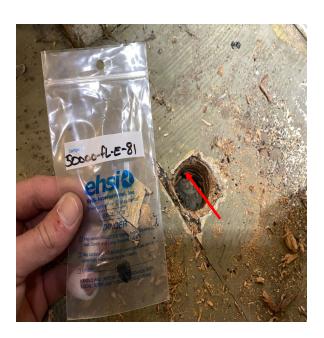
PHOTO #50000-FL-E-81: Non-ACM leveling compound on ACM VAT (pink)

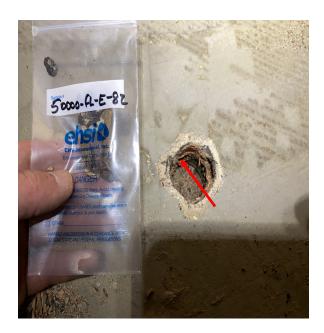
PHOTO #50000-FL-E-82: Non-ACM leveling compound on ACM VAT (tan/beige)

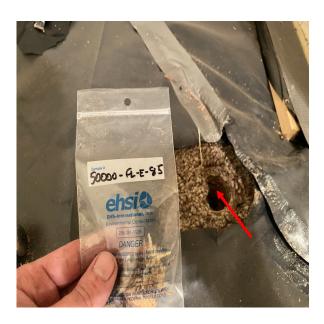
PHOTO #50000-FL-E-85: Non-ACM carpet on ACM VAT (off-white) underneath tarp vapor barrier (all layers not shown)

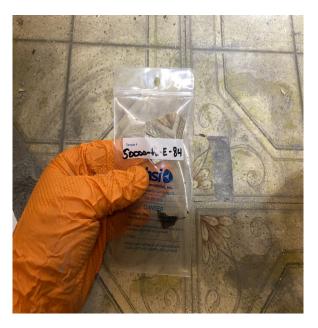
- **58 SF** SVF tile (yellow 12"x12" with 4"x4" pattern) on top of vinyl flooring (beige/green), mastic (clear), ACM SVF (beige/tan with broken rock pattern), and concrete located in Room 4 of the Basement floor.

PHOTO #50000-FL-E-84: ACM 12"x12" sheet vinyl tile (yellow) on ACM SVF (beige/tan w/ broken rock) (all layers not shown)

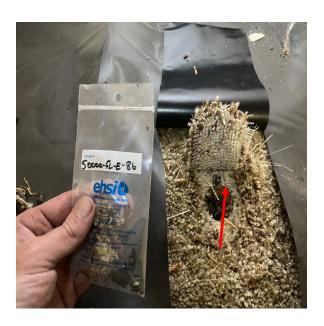
PHOTO #50000-FL-E-86: Non-ACM carpet on ACM VAT (off-white) underneath tarp vapor barrier (all layers not shown)

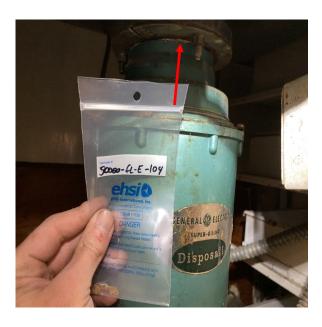
PHOTO #50000-FL-E-104: ACM plumber's putty (tan) on single ceramic sink w/ cabinet

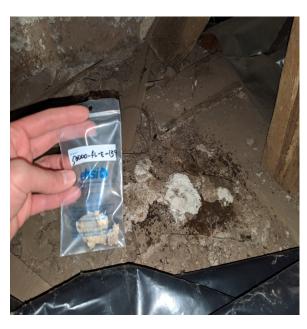
PHOTO #50000-FL-E-139: ACM TSI (white, fibrous/mudded) debris on dirt floor next to water expansion tank

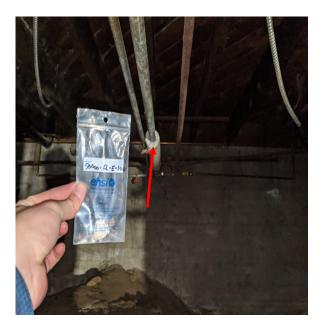
PHOTO #50000-FL-E-140: ACM TSI (white, fibrous/mudded) under non-ACM cheese cloth around 2" OD pipe
