Class V Underground Injection Control Inspection Report

Facility Name: Lapwai School District #341
Facility Address: 204 District Road, Lapwai, Idaho 83540
Facility Mailing Address: P.O. Box 247, Lapwai, Idaho 83540
Facility Phone Number: 208-843-2622
Latitude: 46.39639
Longitude: -116.80432
Facility Participants:
 Alan White, Maintenance Director
 Dan Swearingen, Transportation Supervisor

Inspection Date/Time: 6/12/12, 9:30 a.m. – 11:33 a.m.

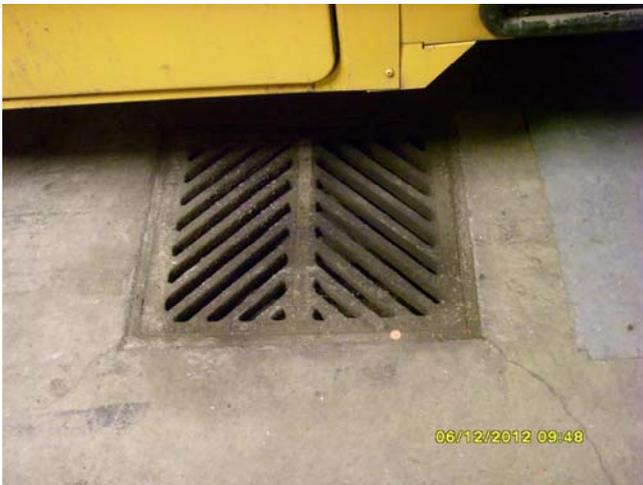
A floor drain is located in the bus bay. The floor drain is covered with a square grate and below the grate is a turned down elbow pipe.

Photo: Floor drain in bus bay.

Mr. White and Mr. Swearingen both think that the bus bay floor drain is connected to the community sewer system. Mr. Swearingen thought he remembered that the bus bay floor drain was connected to the sewer before the floor was poured. According to the facility representatives, they have never needed to clean out the floor drain.

Floor wash water and snow melt have entered the bus bay floor drain. No cleaning agents are used when the floors are washed. Buses are not washed in the building. The facility representatives were not aware of any spills that have entered the floor drain. Spills are managed with floor dry. The inspectors did not observe any shop sinks in the bus bay.

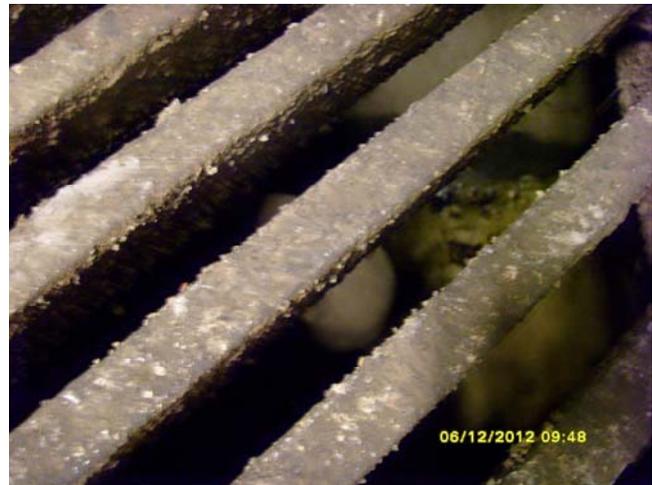
Photo: Looking at turned down elbow pipe under grate in floor drain in bus bay.

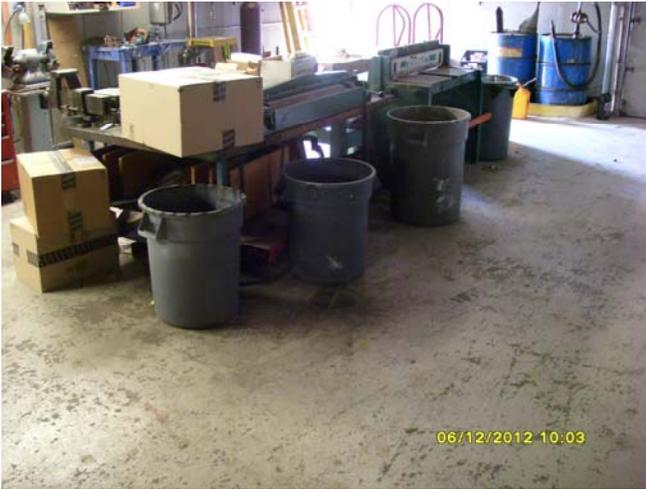
A round floor drain is located in the equipment bay. The inspectors observed sediment below the drain cover but did not observe any piping leading into or out of the sides of the drain. When asked where the floor drain discharges, Mr. Swearingen phoned Jim, the former maintenance supervisor, and relayed that Jim said it discharges to a drywell under a parking space near the office door on the east side of the building.

Photo: Floor drain in equipment bay.

Floor wash water and snow melt have entered the equipment bay floor drain. No cleaning agents are used when the floors are washed. Buses are not washed in the building. The facility representatives were not aware of any spills that have entered the floor drain. Spills are managed with floor dry.

The inspectors explained that if the drain in the equipment bay discharges to a drywell, the EPA would be concerned about the risk to drinking water resources. Mr. White committed to work on trying to find out where it discharges. The inspectors also explained that drywells and other injection wells typically are not allowed within the 100-ft sanitary control area around a public water system well. If the drain cover located 36 ft away from the well house is a drywell that discharges bus wash fluids underground, the EPA would be concerned about the risk to drinking water.

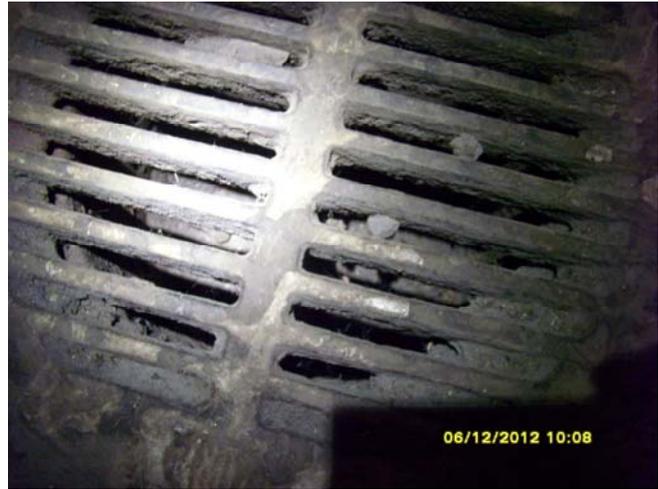
Photo: Looking into equipment bay floor drain.

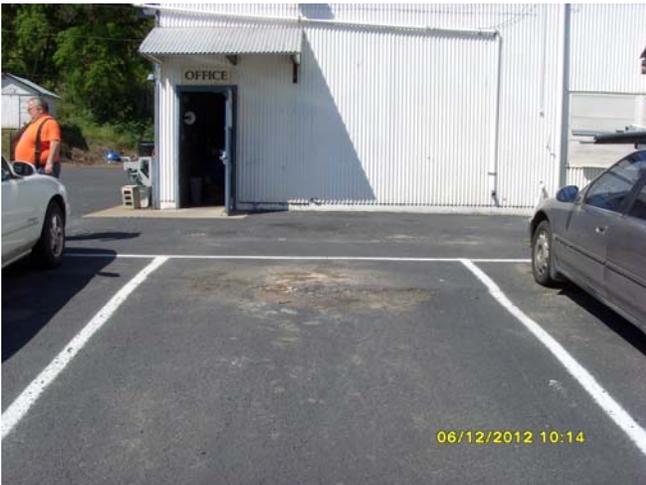
Photo: Looking west at parking space under which the facility representatives think the drywell is located.

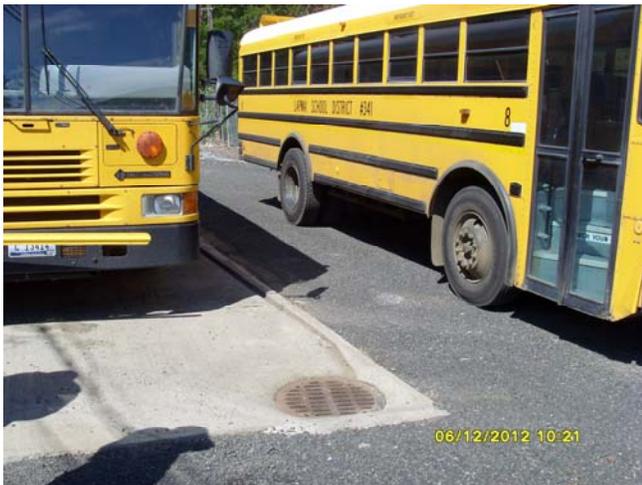
A drain cover is located on the cement pad in the bus wash area. Another drain cover is located east of the cement pad. The drain cover to the east is located near a well house in which one of the public water system wells is located. The inspectors used a tape measure and determined that the distance between the drain cover closest to the well house and the exterior of the well house is 36 feet.

Photo: Bus wash area and drain cover on cement pad.

The facility representatives referred to the drain covers as drywells but also explained that they think both drains are connected by piping to a drywell located in the elementary school playfield north of the transportation and maintenance facility; they think the drywell in the elementary school playfield may be the final discharge point for the bus wash fluids. The facility representatives did not know if any of the

bus wash fluids discharge underground beneath the drain covers. Mr. Swearingen ran water into the drain on the cement pad and showed the inspectors that the water flowed into the drain to the east.

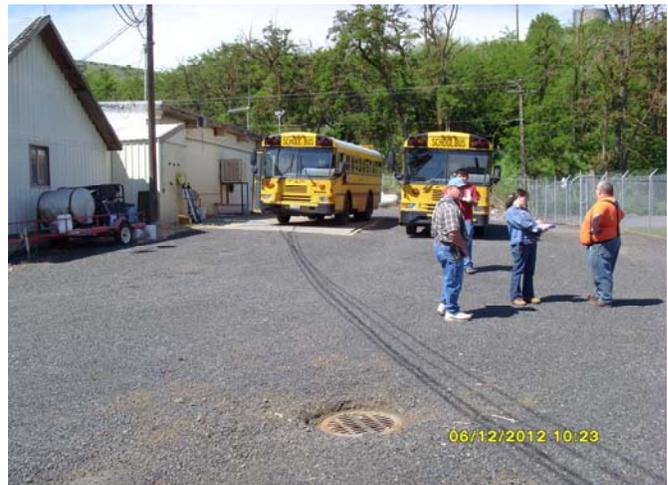
Photo: Looking west toward bus wash on cement pad from drain cover closest to well house.

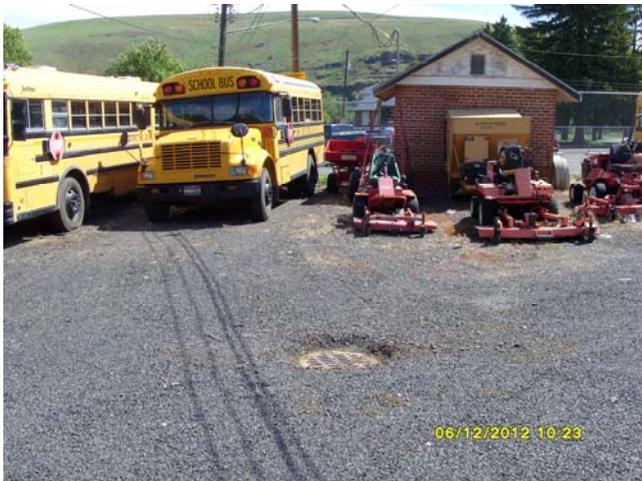
Photo: Looking east toward well house.

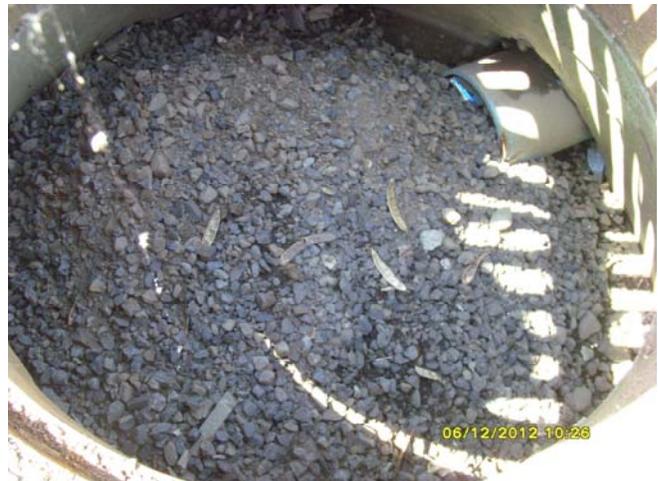
Photo: Looking south under cover of drain closest to well house.

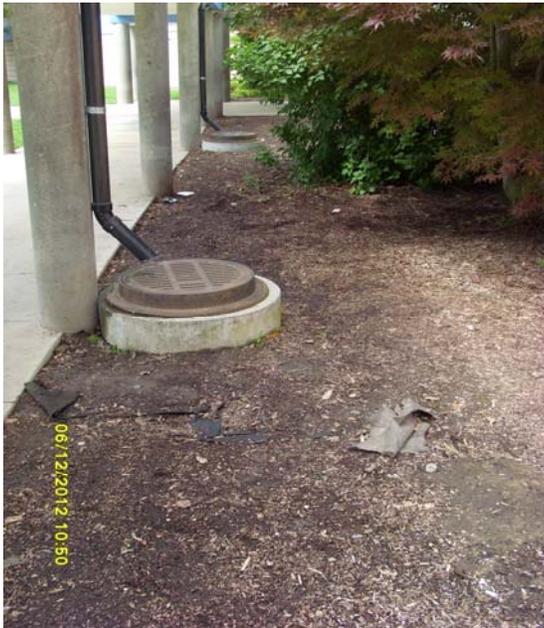
Two roof drains are located on the front of the elementary school building. Mr. White thought that the roof drains either discharge underground or the runoff is routed to a nearby creek. He explained that the drains discharge through grates into dug areas filled with drain rock. The dug areas are approximately 4-5 feet deep and approximately 4-5 feet in diameter.

Photo: Roof drains on elementary school building.

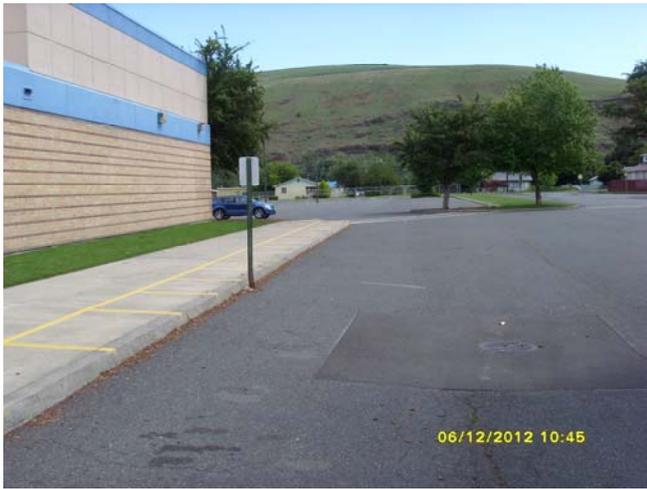
Mr. White also identified two drain covers in the elementary school parking lot that receive stormwater. One of the drain covers is located near the roof drains on the front of the school building. Mr. White identified the drain cover closest to the roof drains as a drywell. The other drain cover is located in the northeast corner of the parking area. Mr. White thought that stormwater collected through the drain cover in the northeast corner discharges to a nearby creek. The inspectors observed a pipe in the side of the drain in the northeast corner of the parking lot that appears to be oriented to the north.

Photo: Stormwater drywell in front of elementary school.

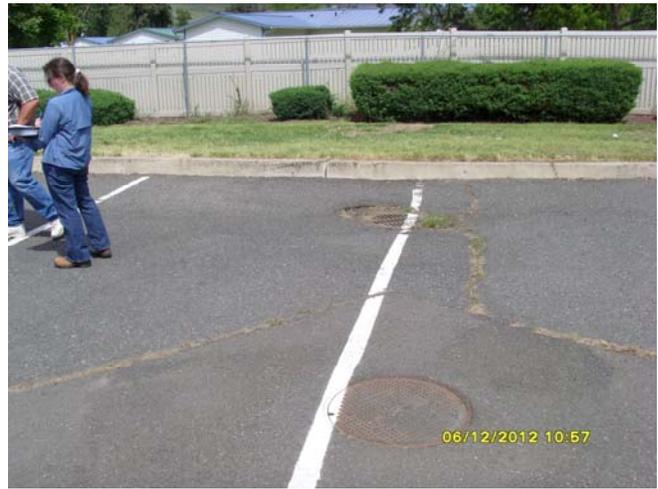
Photo: Grate that collects stormwater in northeast corner of elementary school parking lot.
