Lapwai Creek Watershed Ecological Restoration Strategy

Nez Perce Tribe

Nez Perce
Soil and Water
Conservation District

Spring 2009

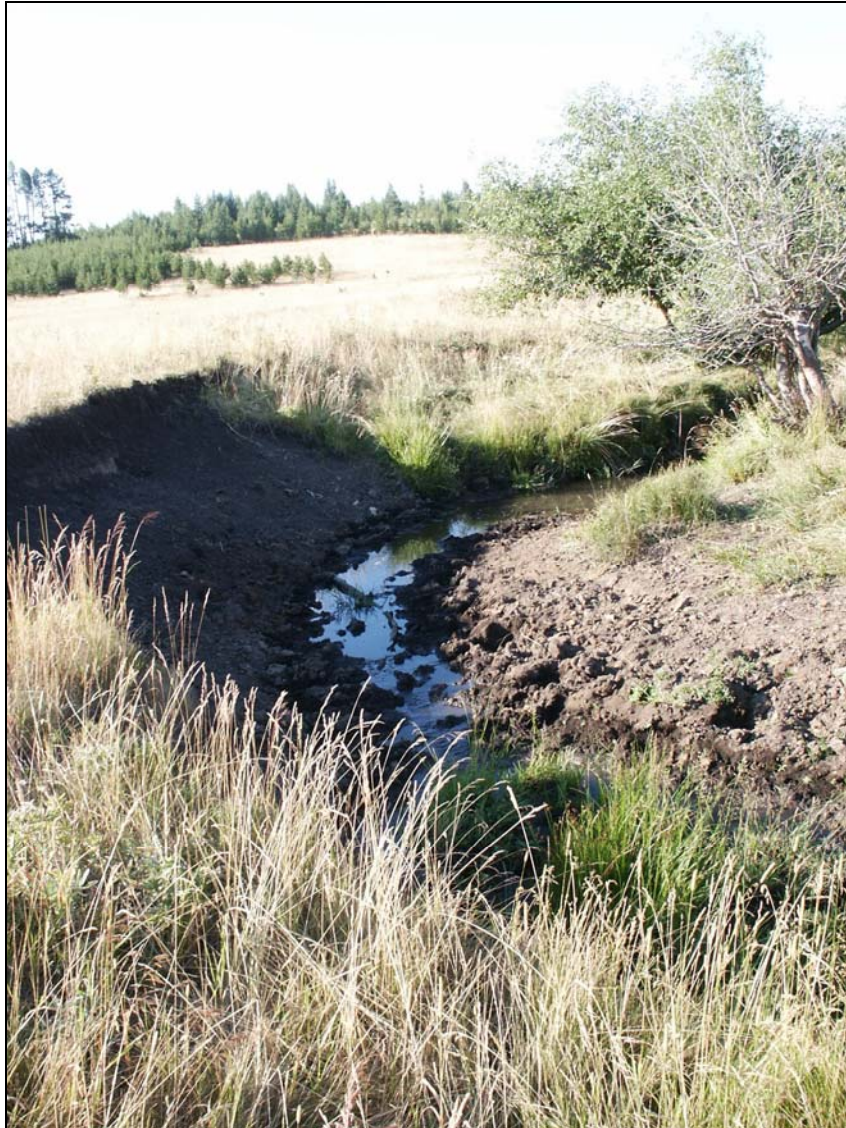
Impacts from grazing in the headwaters of Mission Creek

Grazing occurs in the Lapwai Basin year-round. Typically, cattle graze in the canyons in spring, mountains in the summer and fall and are moved to feedlots during the winter. Within Nez Perce County, 41% of those feedlot operators allow access to streams while only 16% provide off-site watering opportunities (District, 1998). Impacts from these operations include accumulation of animal waste in a confined area, leaching of animal waste, stream-side degradation, and impaired water quality. According to the District's Confined Animal Feeding Operation Inventory and Analysis (1998), Lapwai Creek is considered to be at high risk for water quality impairment. Sweetwater and Mission Creeks are considered to be at moderate risk, and Webb Creek is considered to be at low risk. Rotation schedules, grazing animals better-suited for the area (including sheep), development of off-site watering systems, and riparian area fencing, with the exclusion of agriculture waste systems, etc., are a few tools available to help dissipate the effects of grazing near salmonid streams.

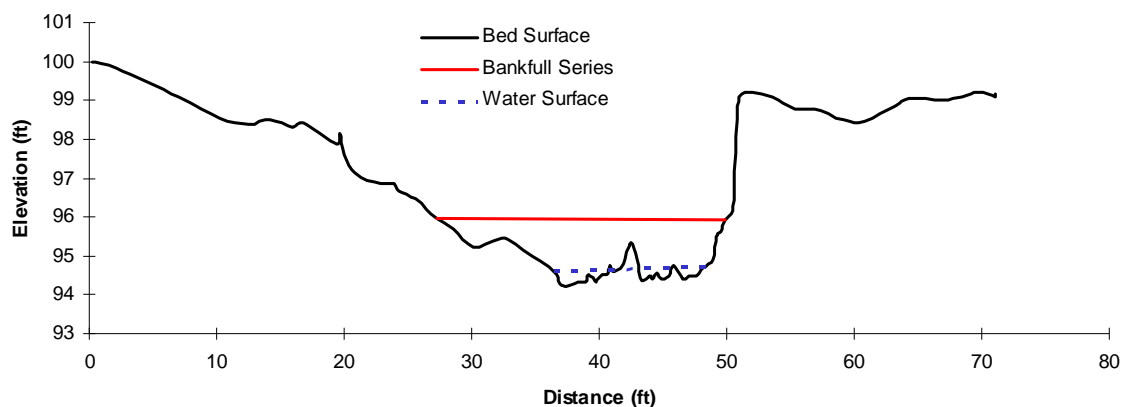
Figure 14. Low Base-flow to Bank-full Ratio Resulting in Poor Ranking

The three year base-flow mean for each site was divided by the derived bankfull cross-section¹¹ to establish monitoring site base-flow to high-flow ratios. Water Quantity rankings of 1-10 were assigned to each assessment unit on the basis of these ratio values. Assessment Units with low ratios, reflecting low base-flow relative to high spring flow events, received high scores (Figure 13) while AUs demonstrating less variability between high and low flow levels received low scores (Figure 14). A score of 1 indicates relatively good water quantity relative within all 10 Aus, and a score of 10 indicates relatively impaired water quantity conditions. This ranking paradigm reflects intent to prioritize restoration within those areas with diminished levels of summer flow relative to total flow available.

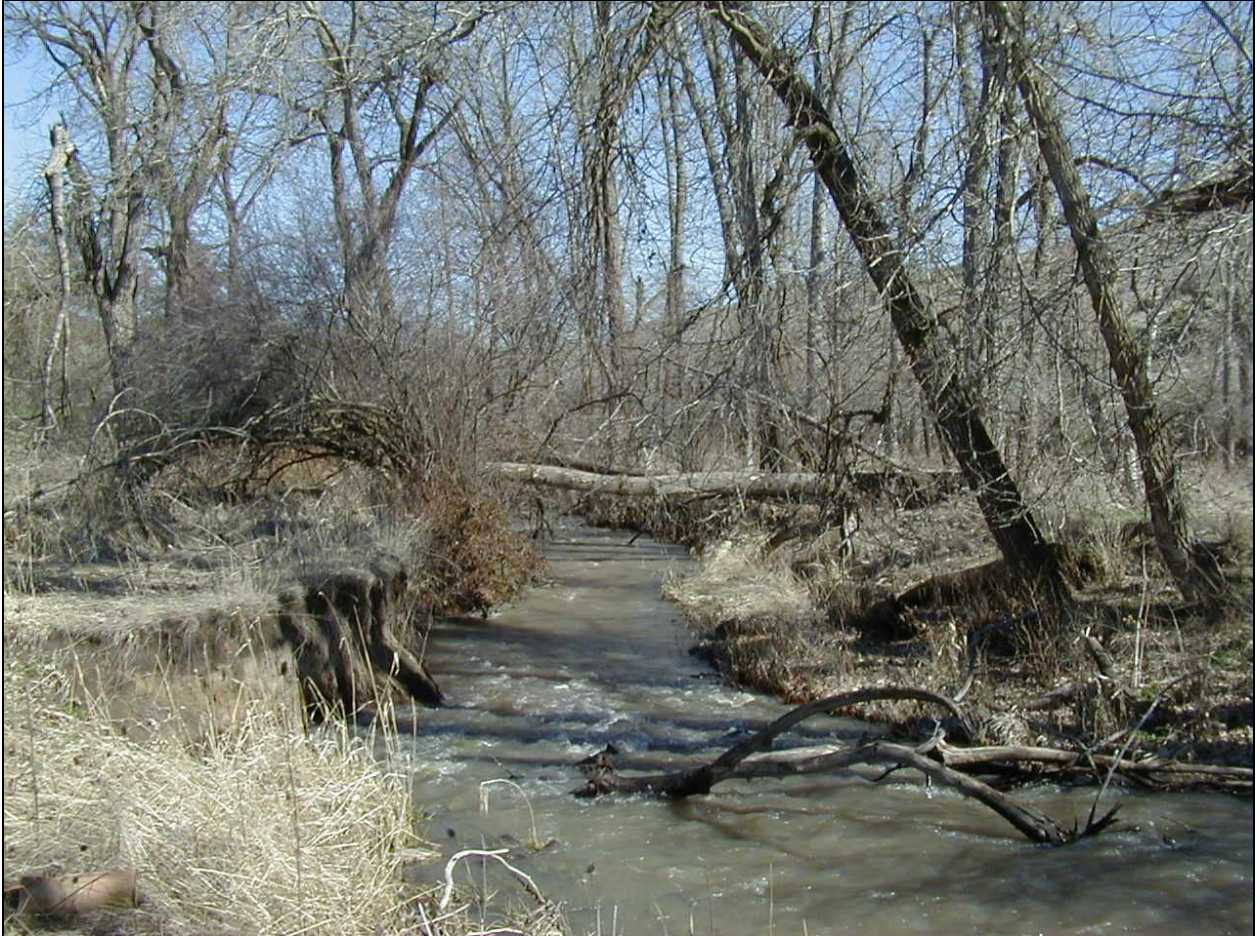
Sweetwater Creek Showing High Turbidity and Evidence of Erosion

Livestock should be removed from within riparian zone, in conjunction with riparian fencing, planting, and off-site water development.

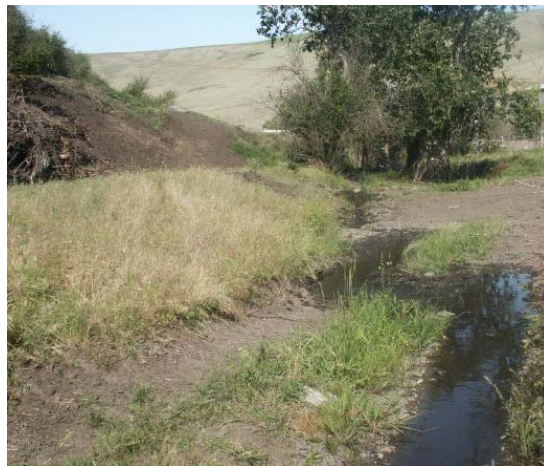
Figure 23. Reach Exhibiting Poor Riparian Habitat on Garden Gulch Road in the Lapwai Creek Basin

Reaches within this group were determined by a combined ranking of riparian cover and canopy cover. Impairment within this group was evident throughout the watershed. Impairment is defined as those reaches with less than 50% canopy cover, less than one active channel width of natural vegetation, a lack of vegetative regeneration, and/or moderately compromised filtering function. Impaired areas typically have invasive weeds, a lack of vegetative density, either grazing or agricultural tillage operations adjacent to channel, and minimal to no vegetative buffer. Figure 22 provides an example of a reach that would rate Poor through the SVAP evaluation.

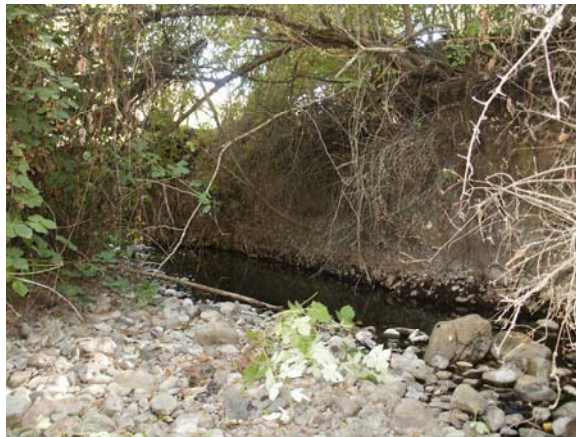
**Figure 25. Reach Exhibiting Poor Channel Condition on Webb Creek
in the Lapwai Creek Basin**

Stream reaches with impaired channel function were ranked through a combination of scores for channel condition, hydrologic alteration and bank stability. Reaches receiving a Poor ranking are typically confined, often by a road or railroad prism, have little to no floodplain access, are actively downcutting or widening, and less than 50% of the reach is channelized or riprapped. Additionally, the channel may be deeply incised or have water withdrawals, with minimal flooding, and unstable banks. Reaches receiving a Fair rating have less than 50% of the channel altered by riprap or channelization; may include braided channels or excess aggradation; dikes or levees may restrict floodplain; channel is incised; banks are moderately unstable; and flooding occurs every 6-10 years. Reaches receiving a Good rating may include evidence of past channel alteration but with significant recovery of the channel, set back dikes/levees providing access to floodplain, moderately stable banks and limited channel incision.

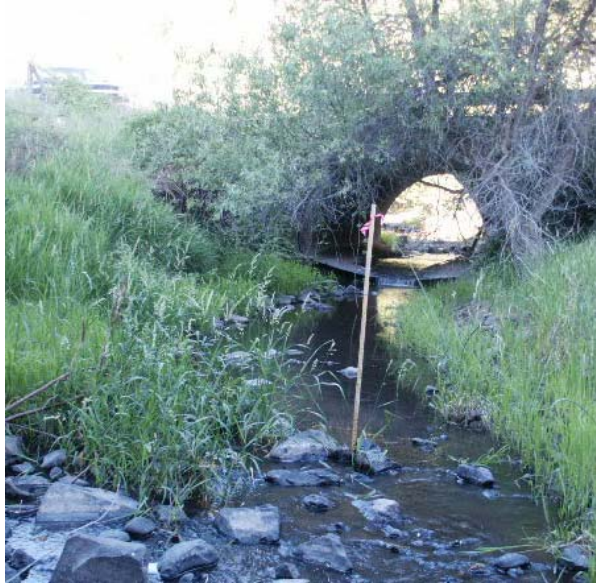
The NPT and the NPSWCD have located passage barriers throughout the Lapwai Creek watershed. These barriers may block passage seasonally or perennially for different life stages of anadromous fish. Barriers located in one reach are recognized to have an effect on upstream and downstream conditions.

**Figure 28. Fish Passage Barrier on Sweetwater Creek in the Lapwai Creek Basin
Culvert was recently replaced with bridge.**

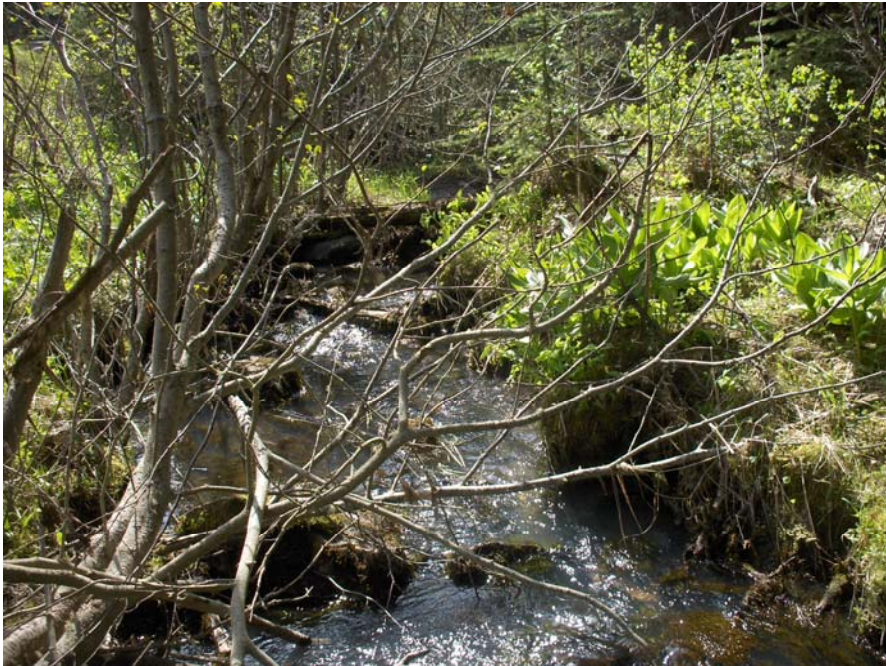
Example of a Protection Reach

Protection reaches are those that received an overall SVAP index rating of Excellent and may be considered reference reaches within the system. Within the watershed, these reaches totaling 3.5 miles are found in Mission Creek, Rock Creek and Sweetwater Creek (Figure 30). Additional Protection reaches may be located within the watershed but were not identified at the time of publication of this report. As these reaches are identified, they will be added to this treatment group.

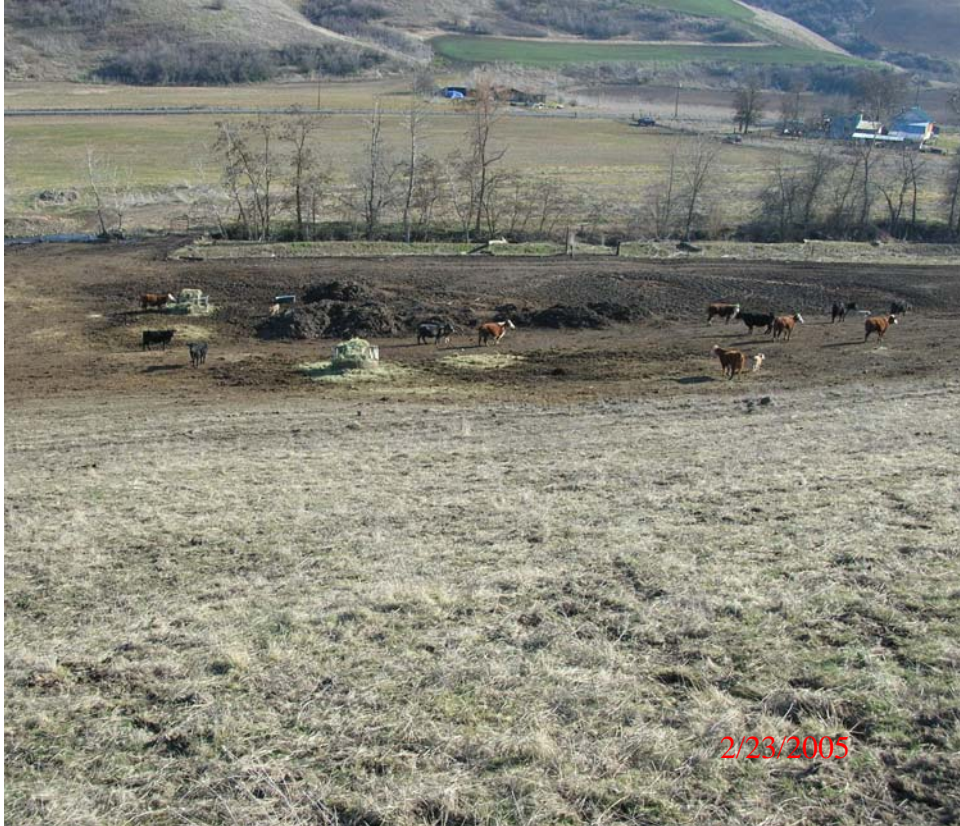
Before Treatment

Work continues on Allotment 365, with additional weed control, plantings, and fence maintenance scheduled for 2009. It may take several years for the some of treatments to translate into changes in SVAP Rating, but benefits of removing aquatic passage barriers, restoring access to the floodplain, and some landscape-level improvements are more immediate.

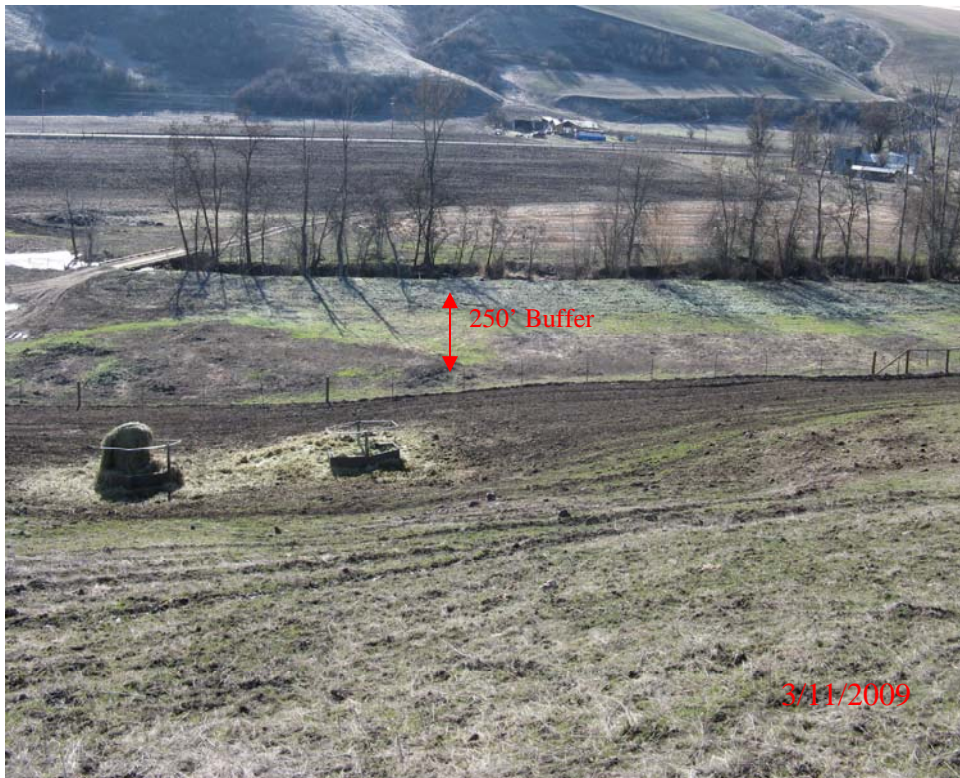
After Treatment
